1 . Buildings at Risk

1 Buildings at Risk

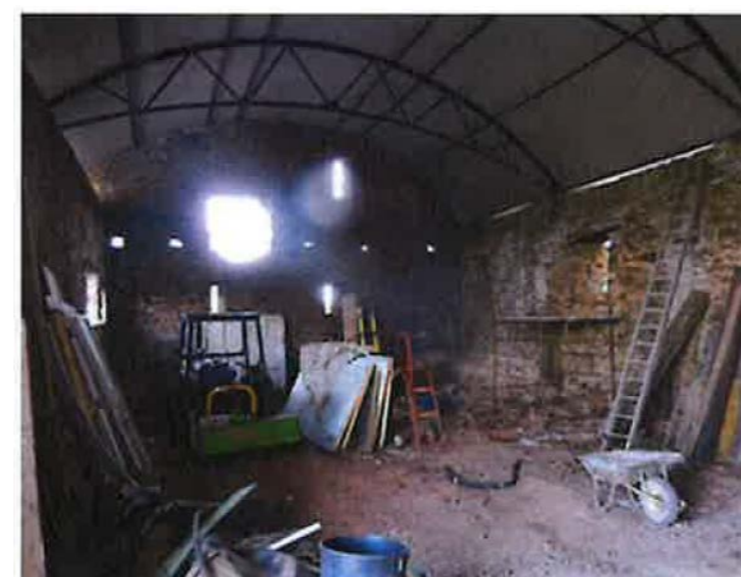
Inside Main Barn repairs 2017

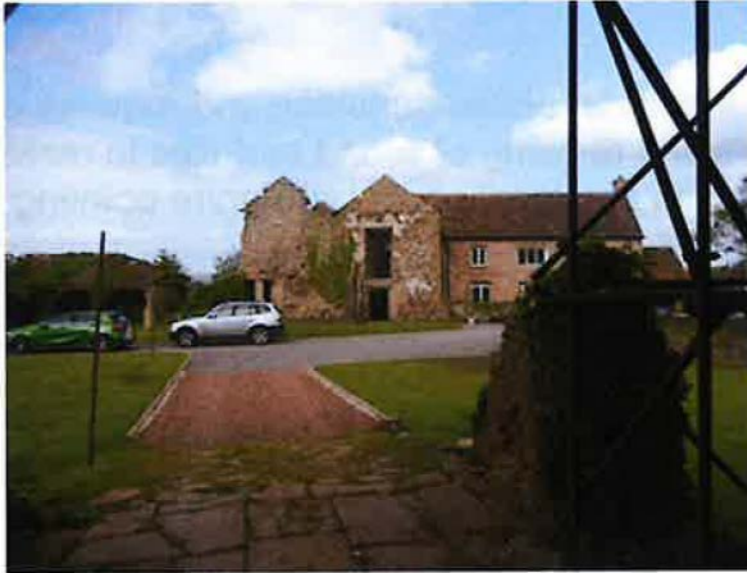
Farmhouse and granary 2017

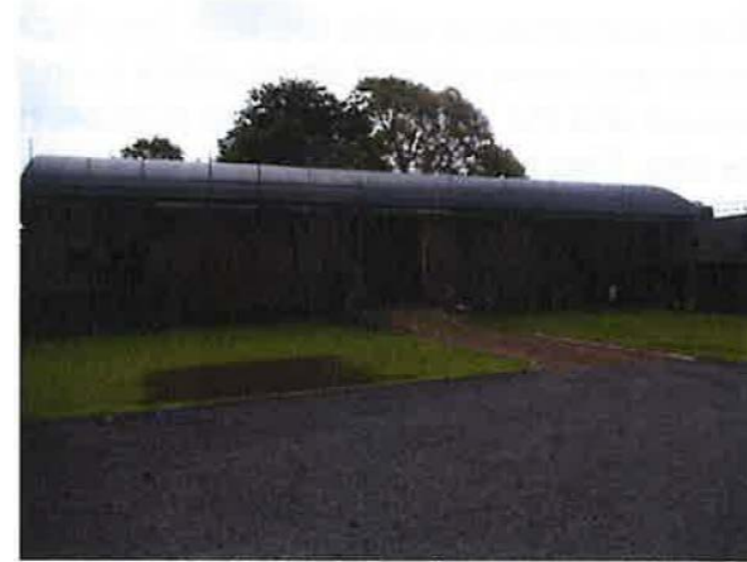
Main barn slow repair 2017

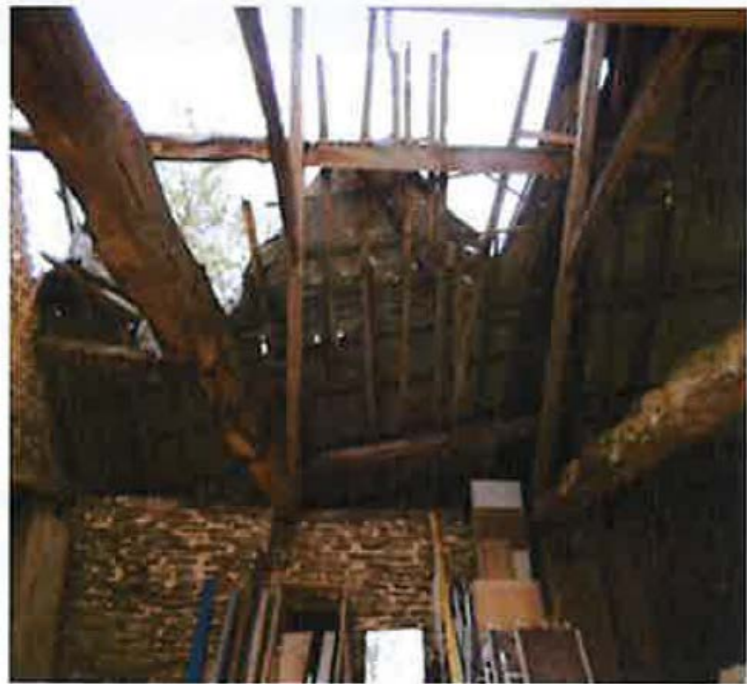
North Barn and Cart Shed 2017 Roof

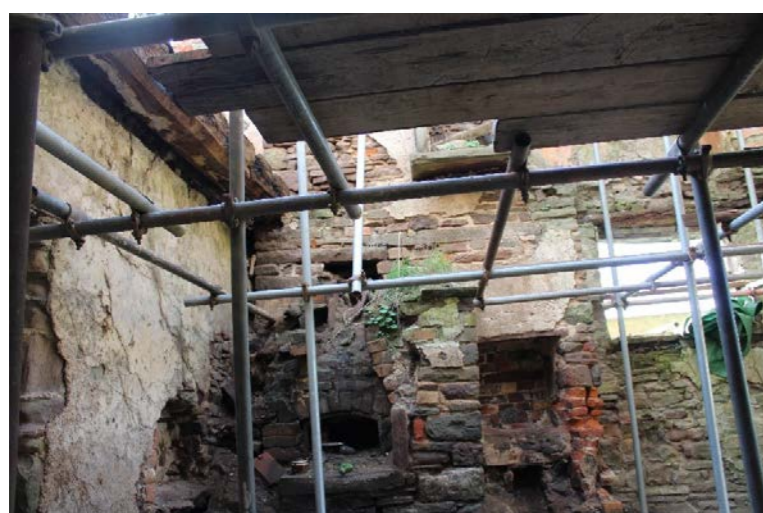
Fig. 21 Granary - Internal View

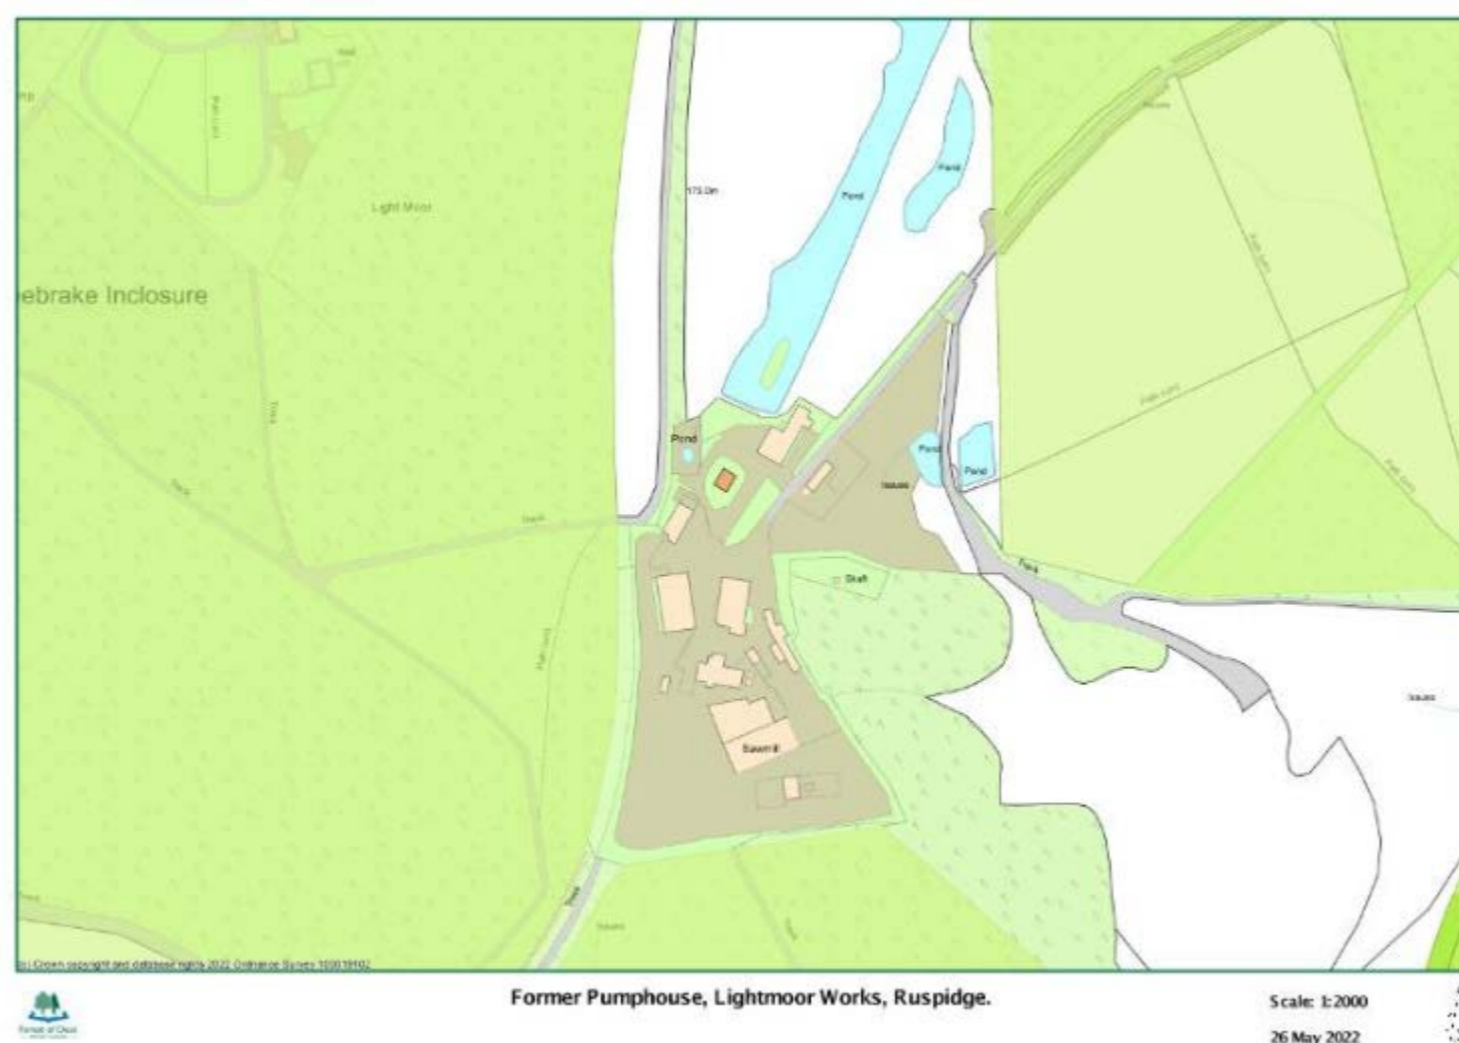
4 Former Pumphouse, Lightmoor Works, Ruspidge**Designated:** Grade II**List entry Number:** 1299226**Parish:** Ruspidge and Soudley**Occupancy:** Private Ownership**Location Map:**

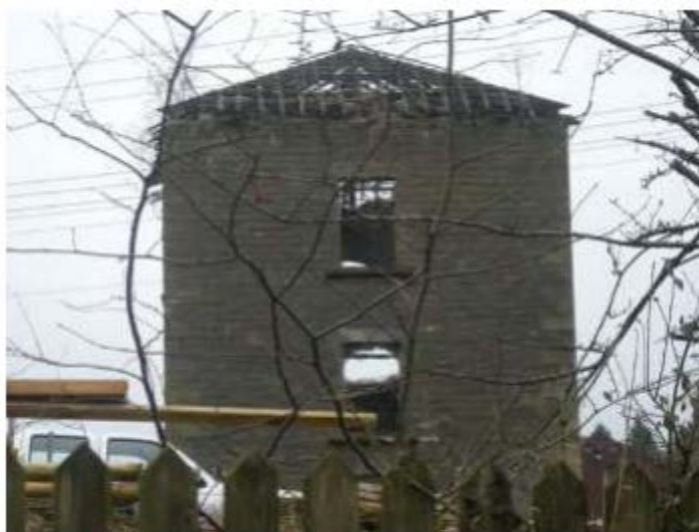
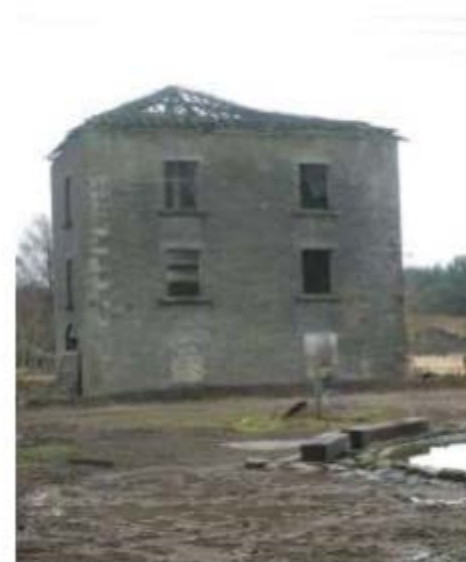
2017 the Pumphouse is only a shell, all the floors are gone, roof structure and the masonry is very loose in various areas. This building is at high risk of collapse.

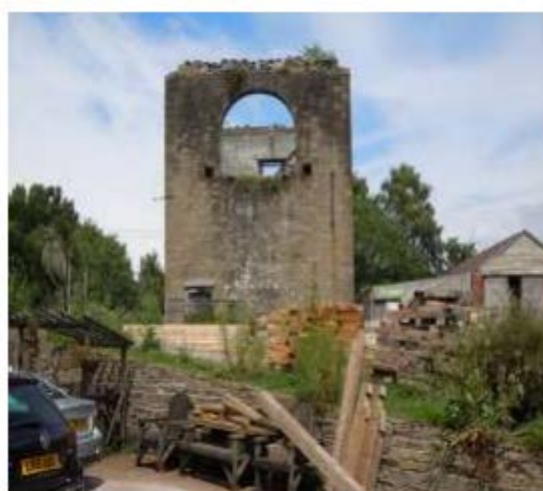
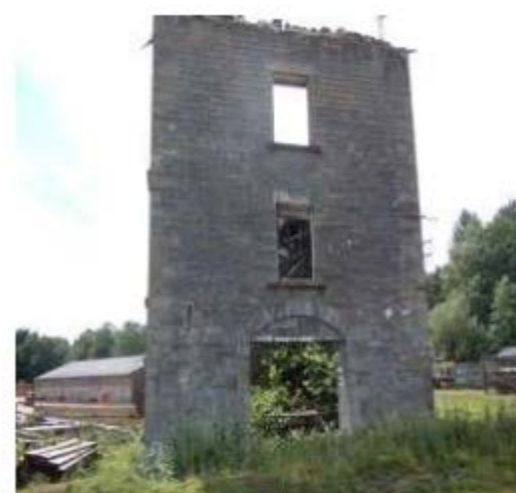
4 . Former Pumphouse, Lightmoor Works, Ruspidge

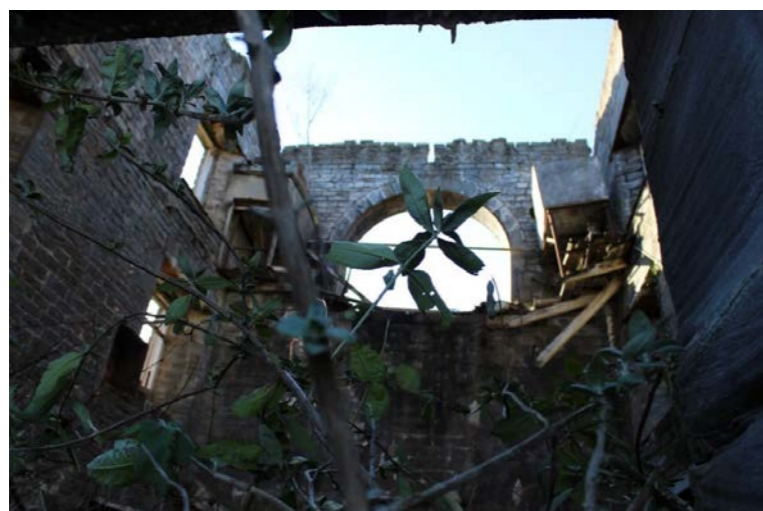
Fig. 5 Internal view with water tanks visible at high level - access was restricted

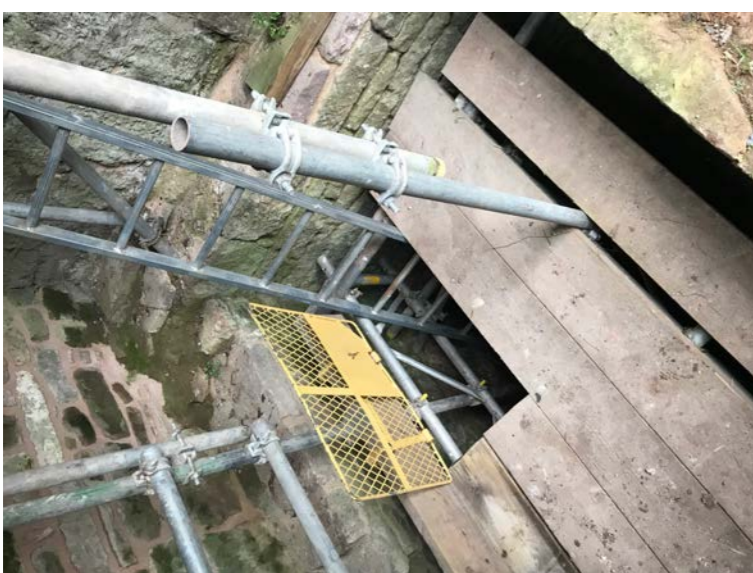
Fig. 3 Ladder access to wheel pit floor

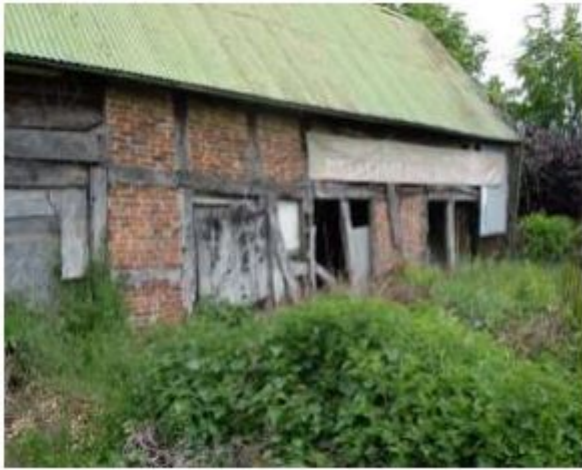
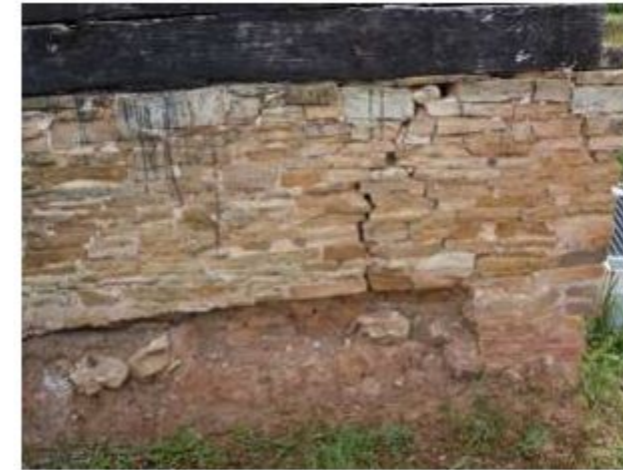
In previous surveys, the building was in danger of collapse, water penetration, external timbers rotten and damaged brickwork.

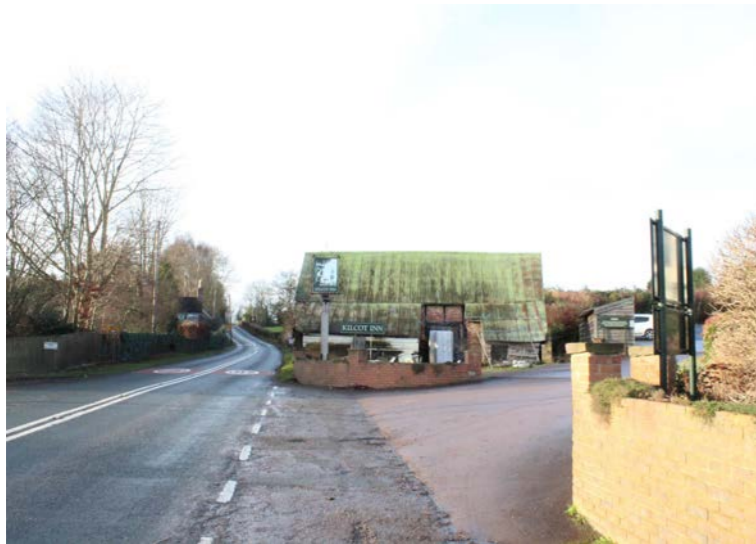
Fig.1 Front elevation - in poor condition

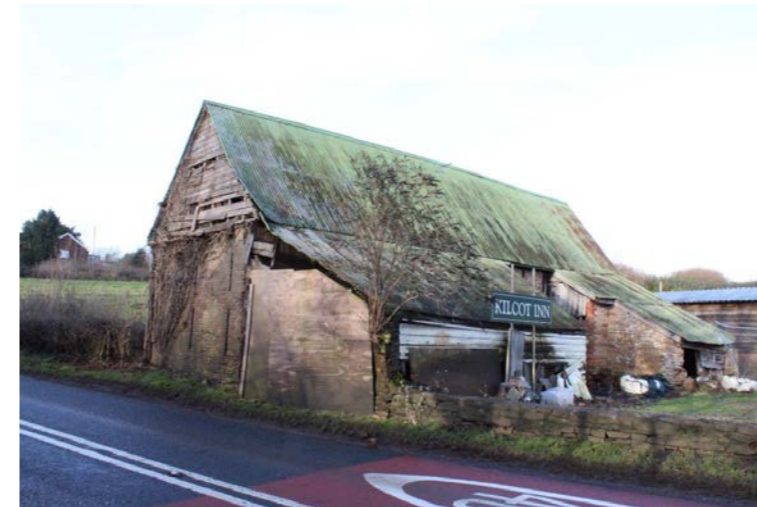
Fig. 2 Front and side elevation - in poor condition

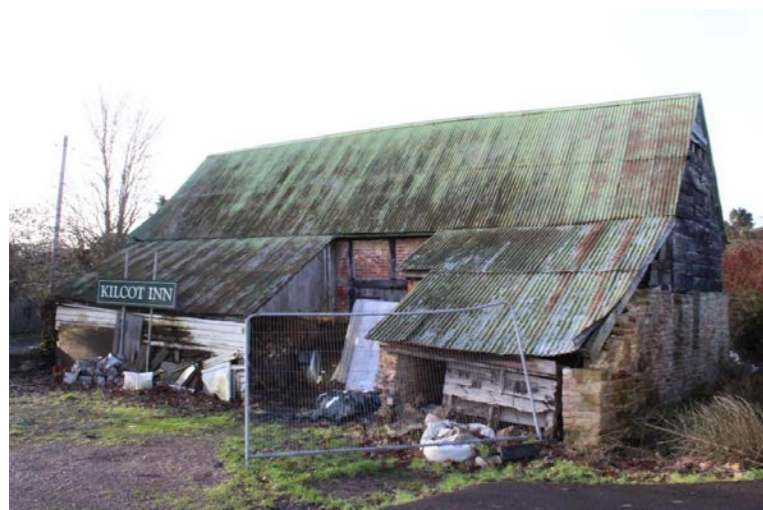
Fig. 3 Front and side elevation - in poor condition

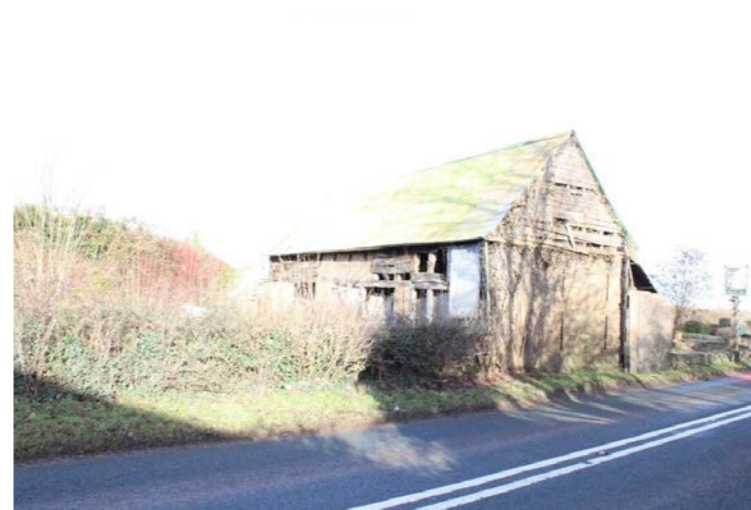
Fig. 4 Rear and side elevation - in poor condition

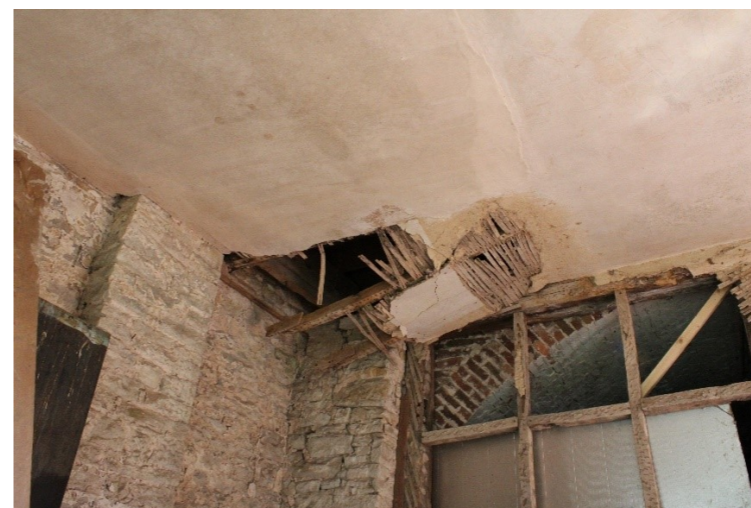
Fig. 6 Internal view of defective lath and plaster ceiling

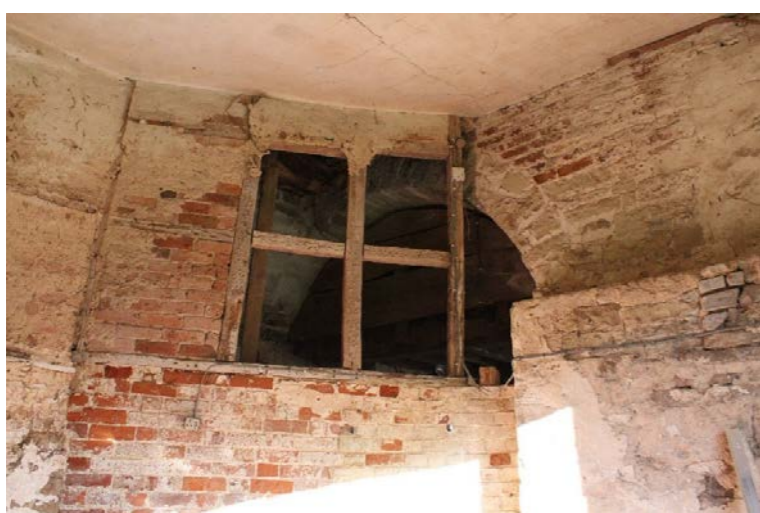
Fig. 7 Internal view

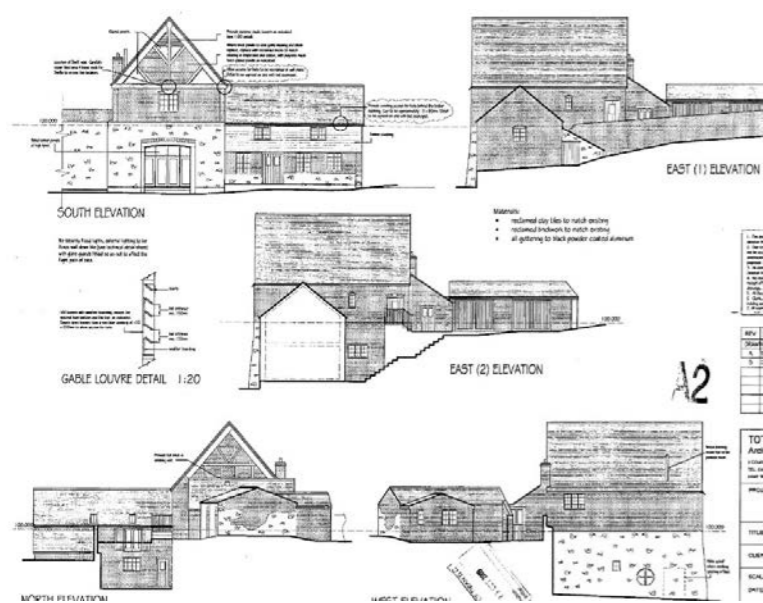
Planning application - elevation drawings

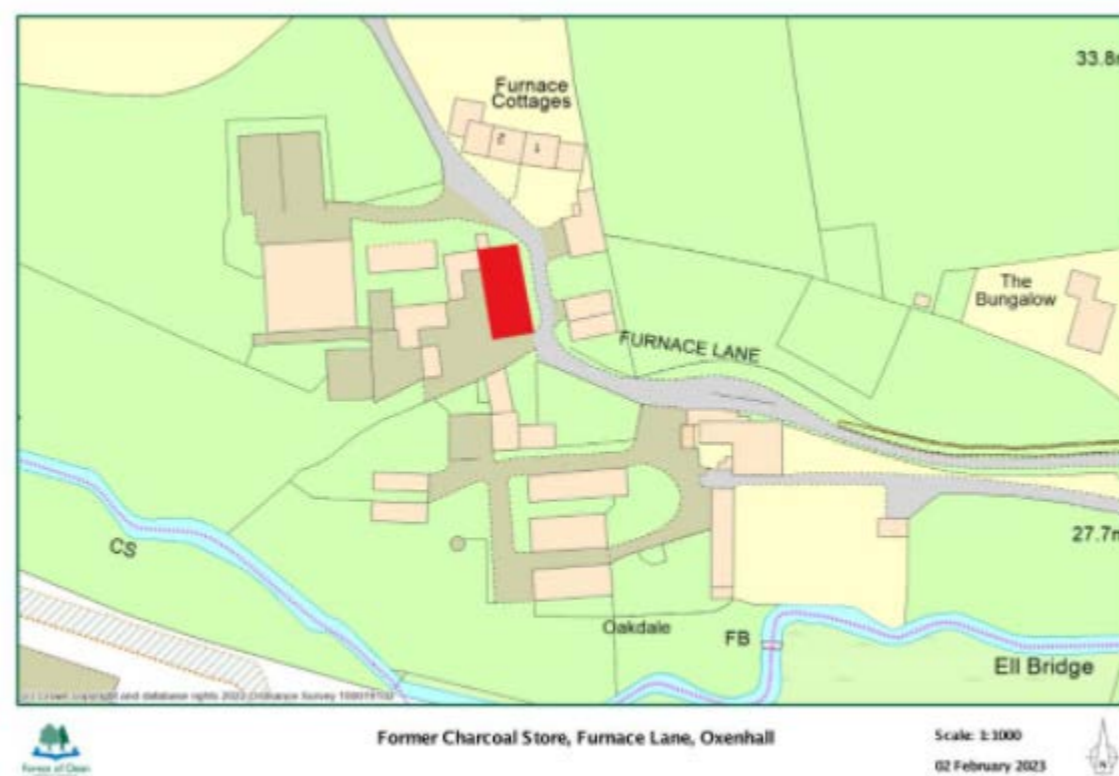
Description: This building is associated with the former blowing house situated close by and is in separate ownership from the blowing house. The former charcoal store was used to store charcoal for the iron furnace and it is believed to be the only remaining 17th century store in the district.

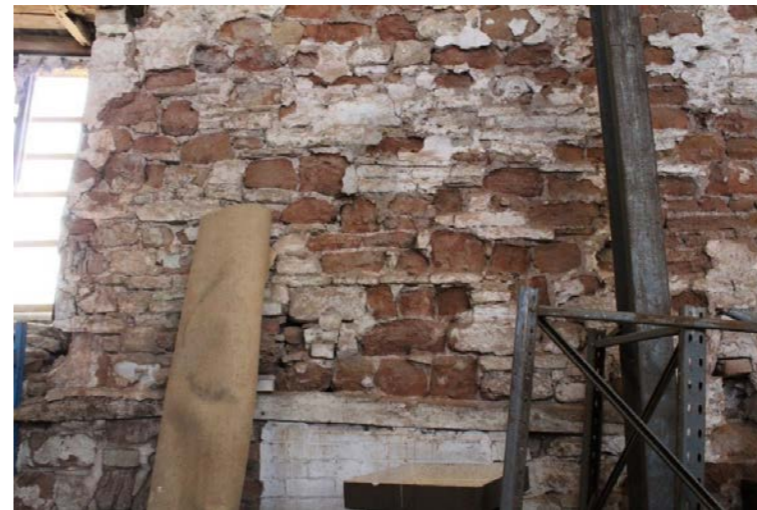
Fig. 6 Internal view of decaying stonework and defective lime pointing

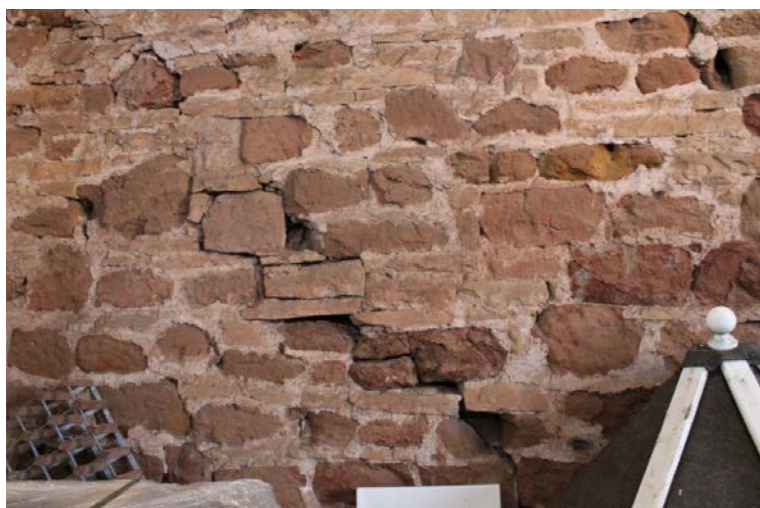
Fig. 7 Internal view of cracking evident in stonework

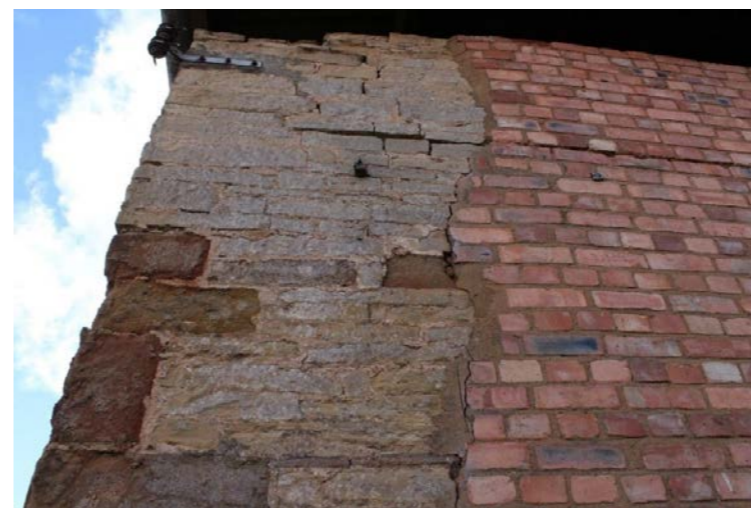
Fig. 8 Cracking evident in between modern infill brick and original stone

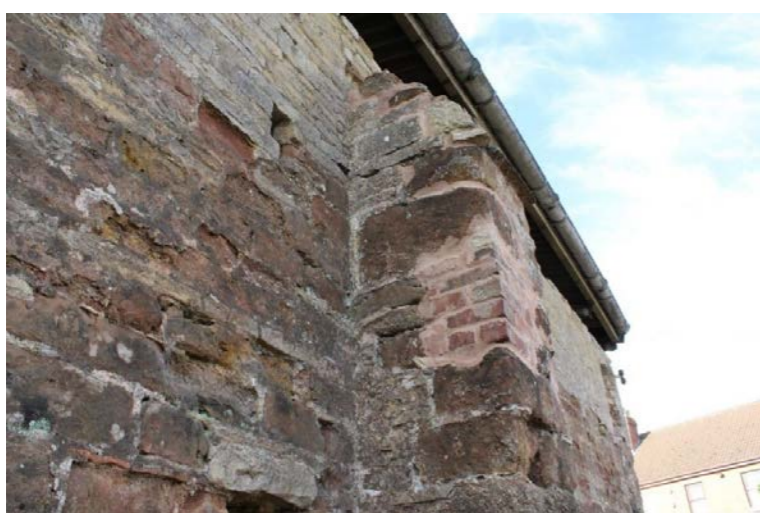
Fig.9 Modern repair to buttress

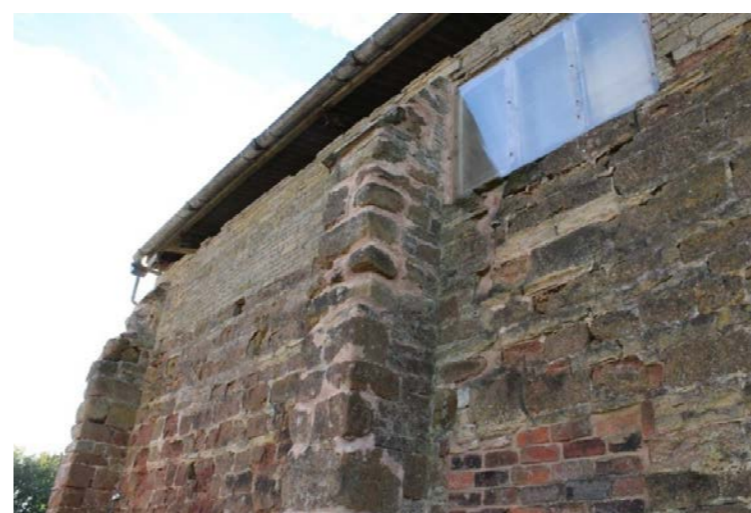
Fig. 10 Modern repointing of buttress

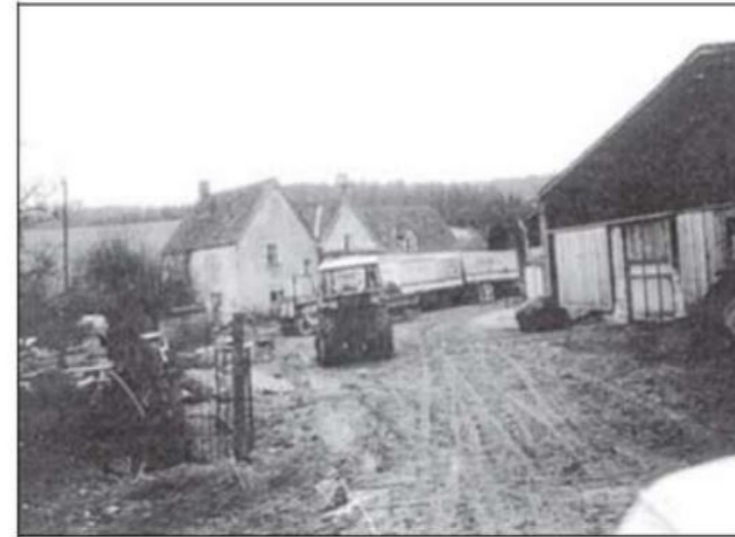
Date of when the photo was taken is unknown

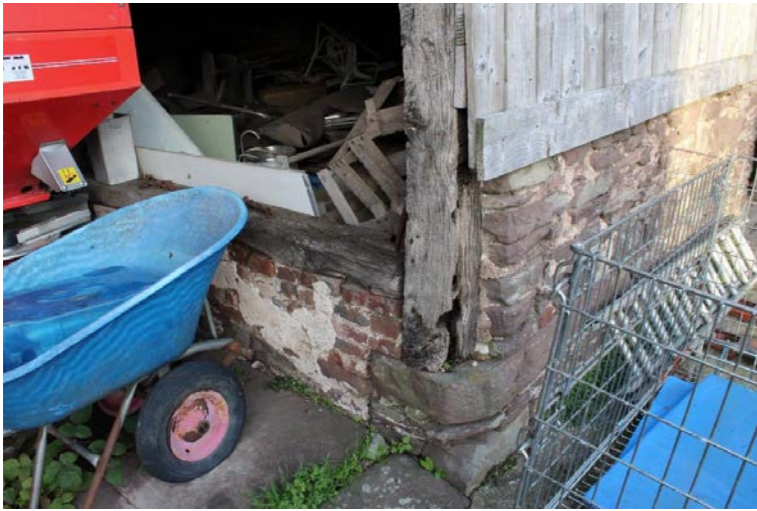
Fig. 5 Defective door frame to side elevation opening 1

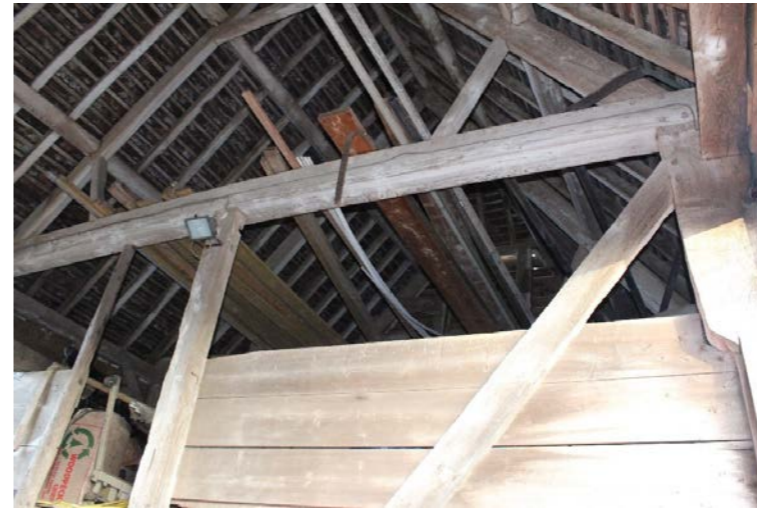
Fig. 6 Internal view of roof

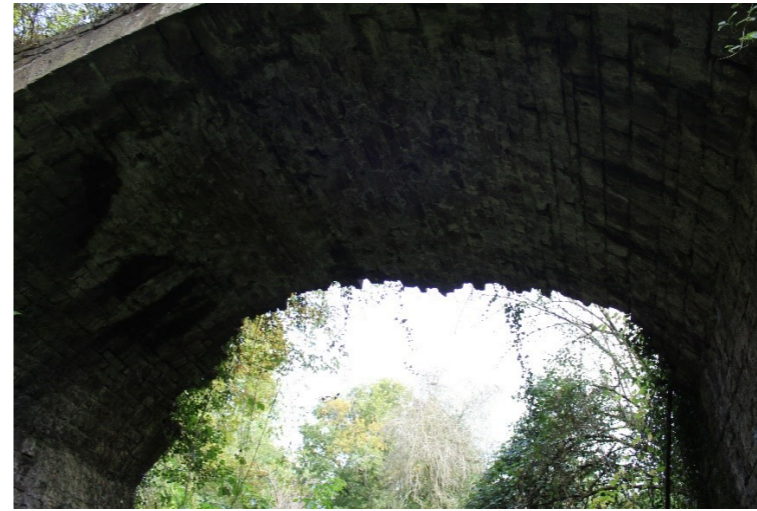
Fig. 6 Intrados of central arch with face voussoirs missing on upper road side

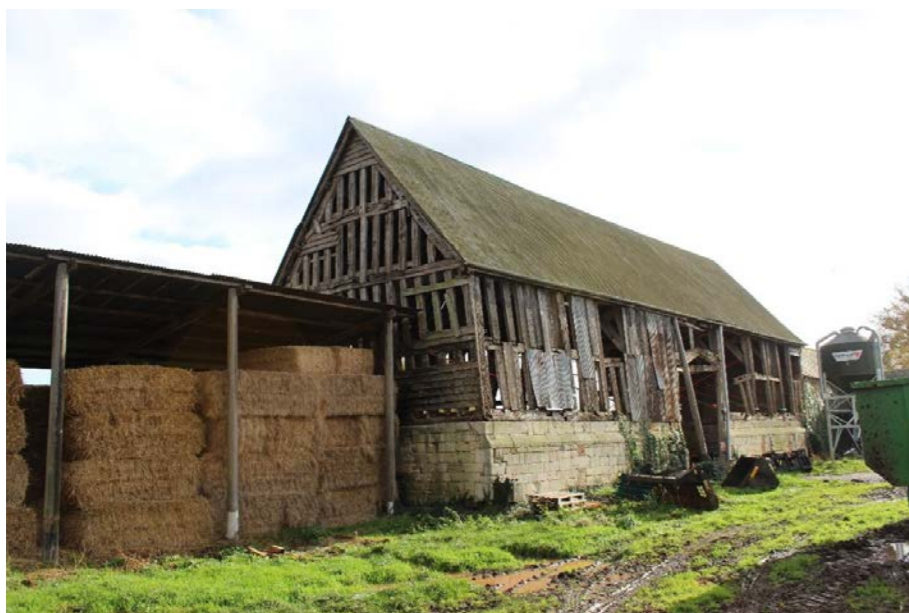
Fig.1 Front and side elevation of the deteriorated barn.

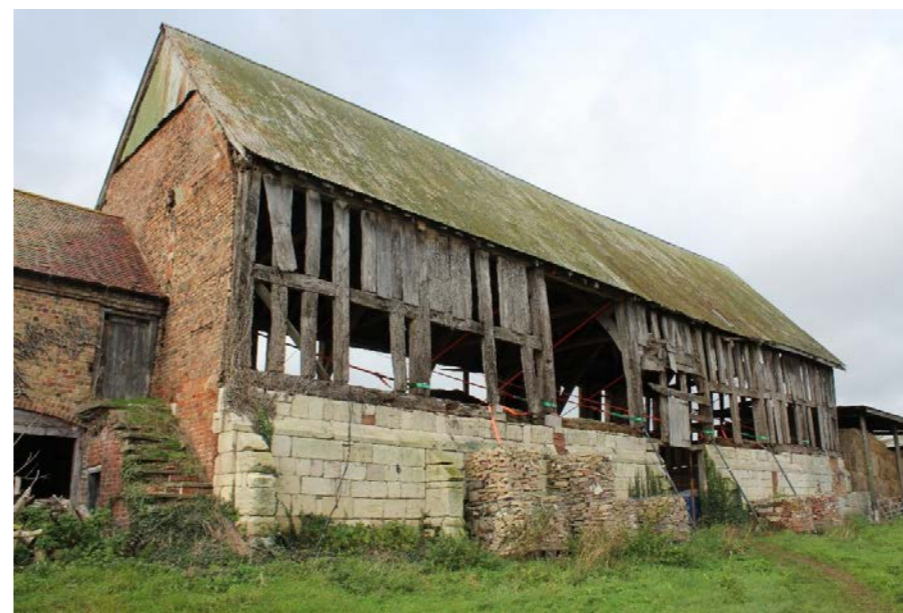
Fig. 2 Side and rear elevation of deteriorated barn.

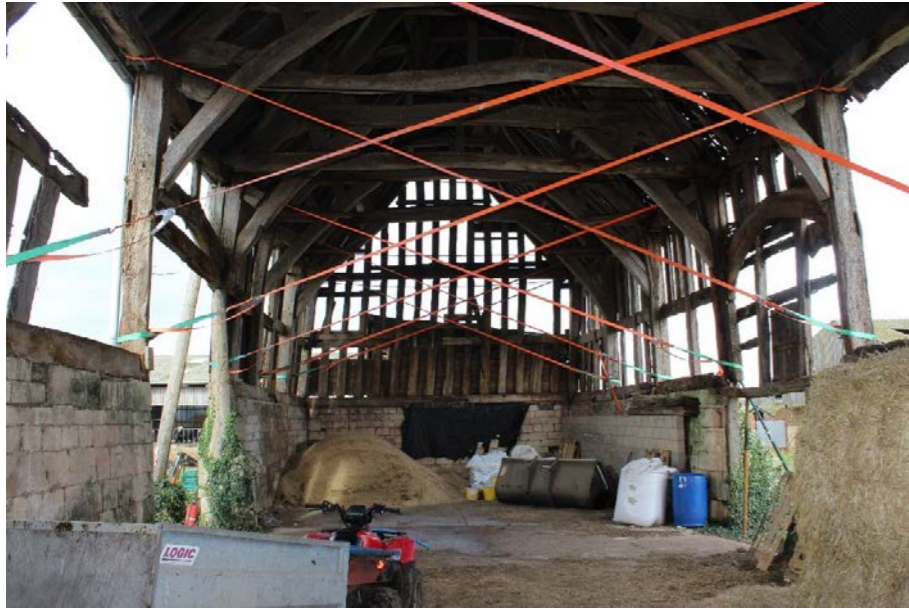
Fig.3 Temporary strapping restraining frame and preventing collapse. Stored materials still accessed by heavy farm machinery.

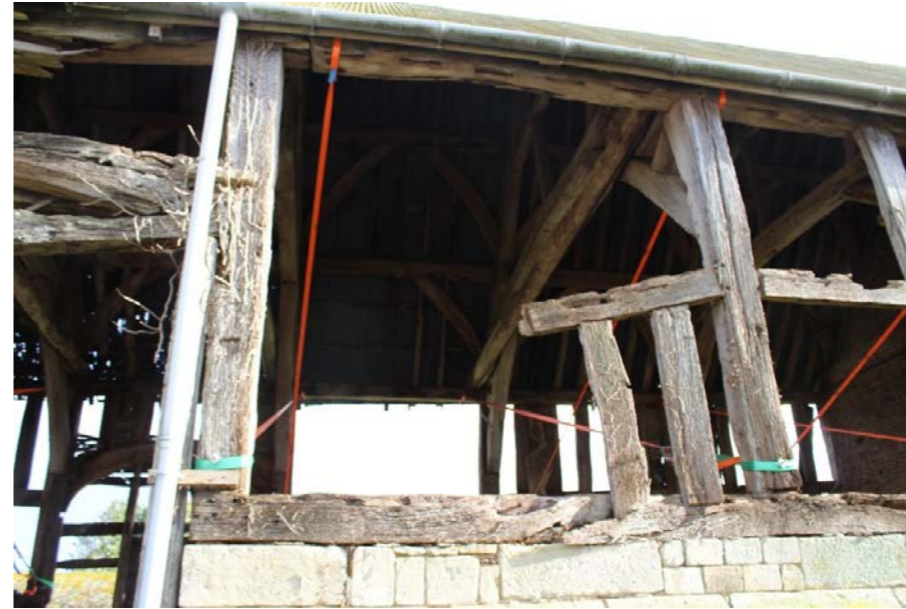
Fig.8 Timber frame exposed to the elements is severely deteriorated and collapsing from the building.

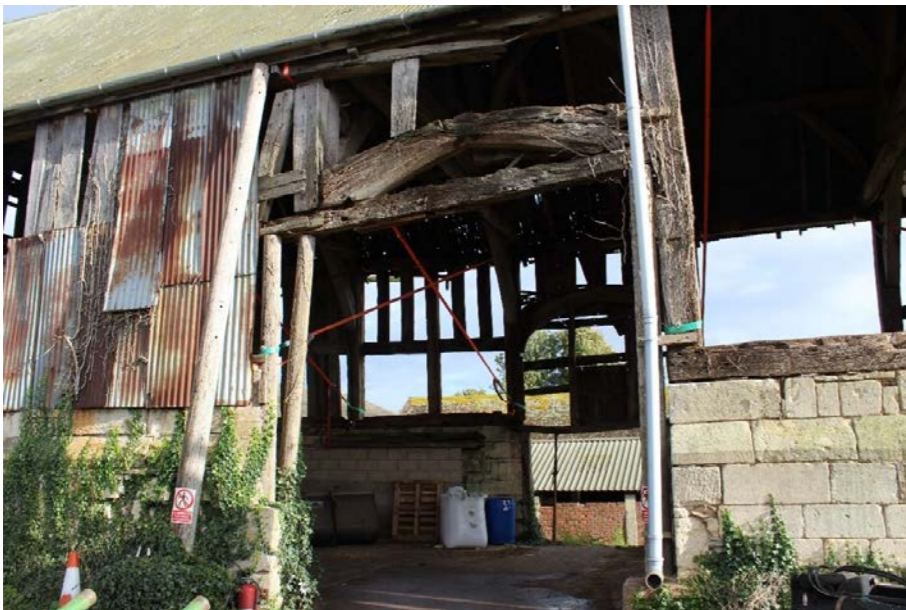
Fig.9 Entrance is in a precarious condition and still used by heavy farm machinery.

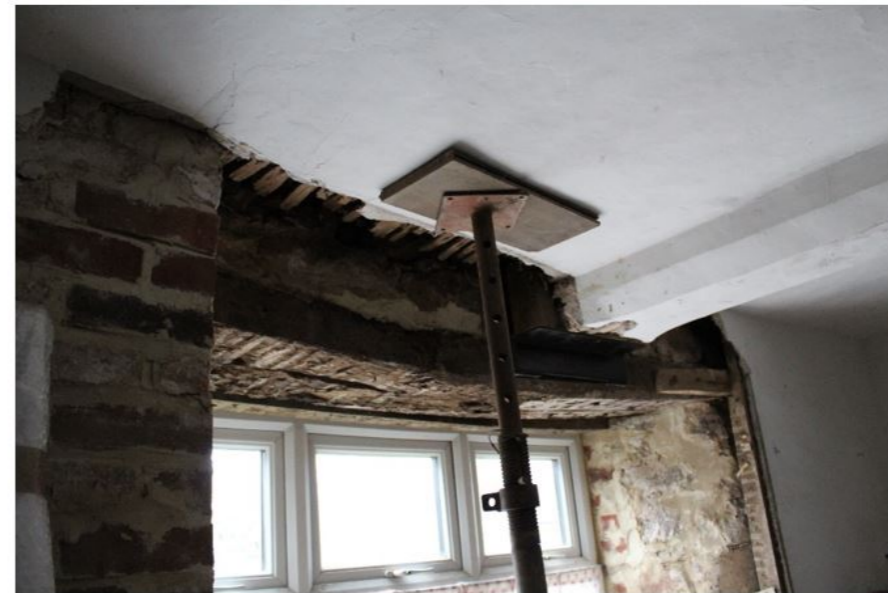
Fig. 7 Repair of beams and temporary propping of floor

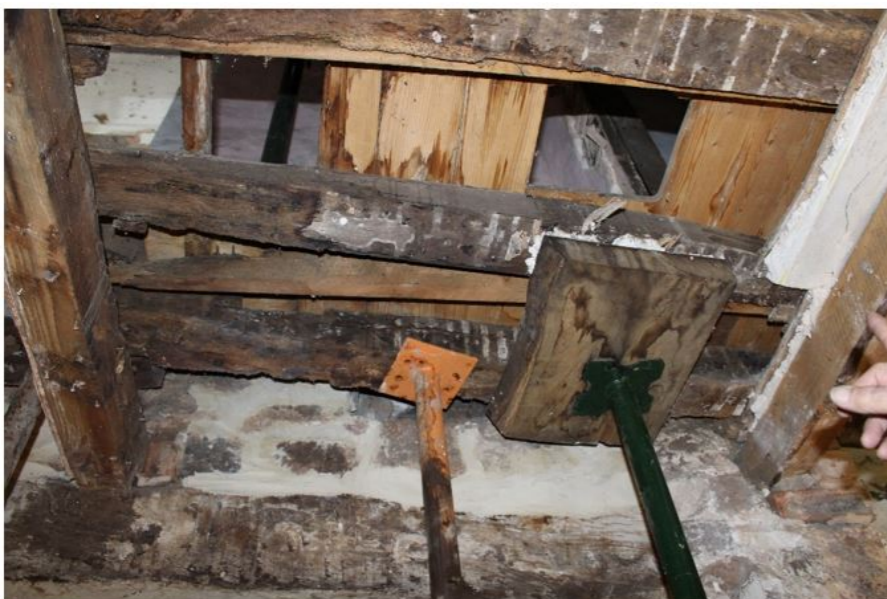
Fig. 8 Repair of beams and temporary propping of floor

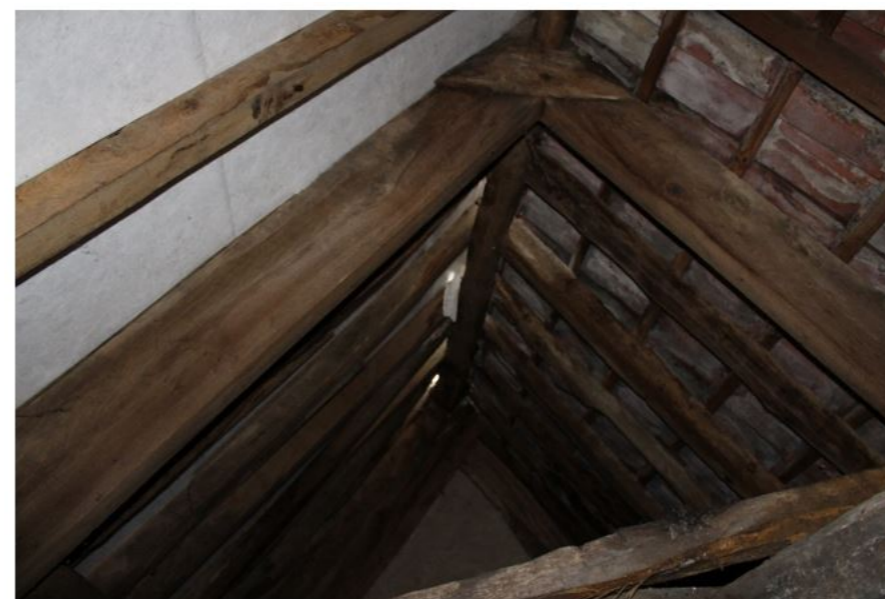
Fig. 9 Repair of roof in progress

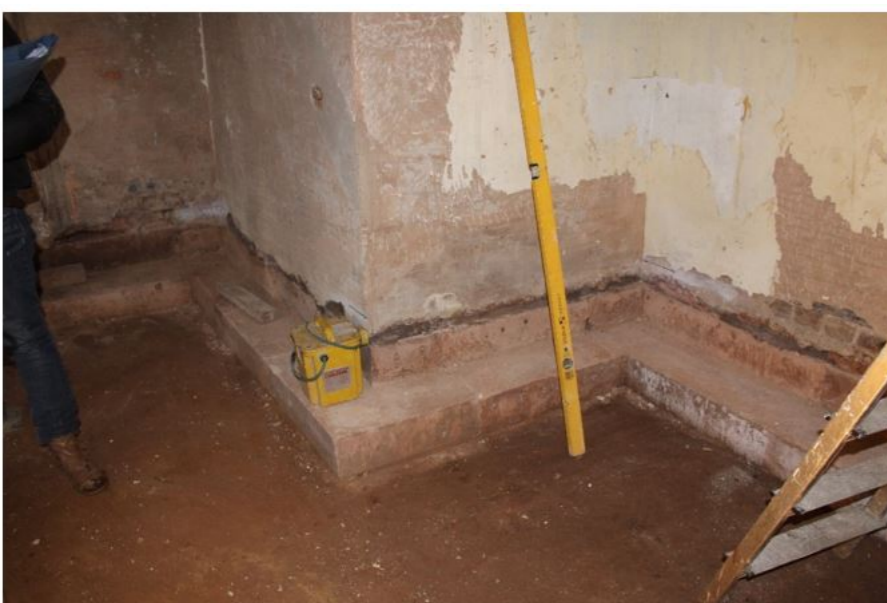
Fig. 10 Underpinning to stabilise walls in progress

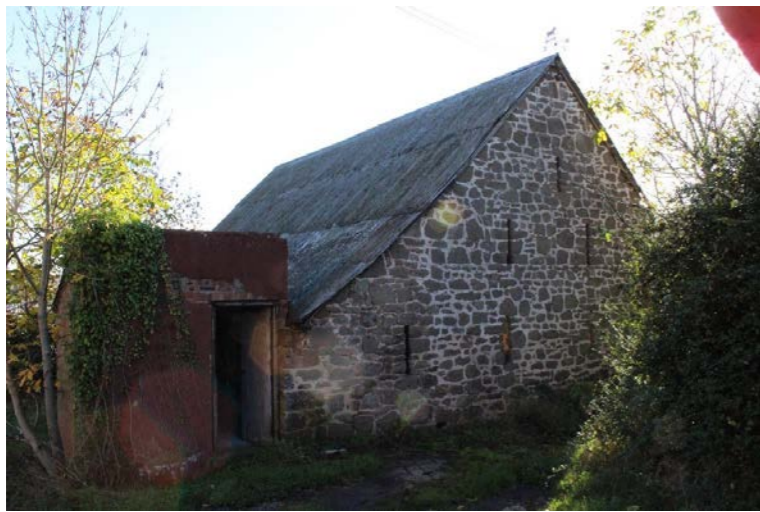
Fig. 1 Side elevation - is in fair condition

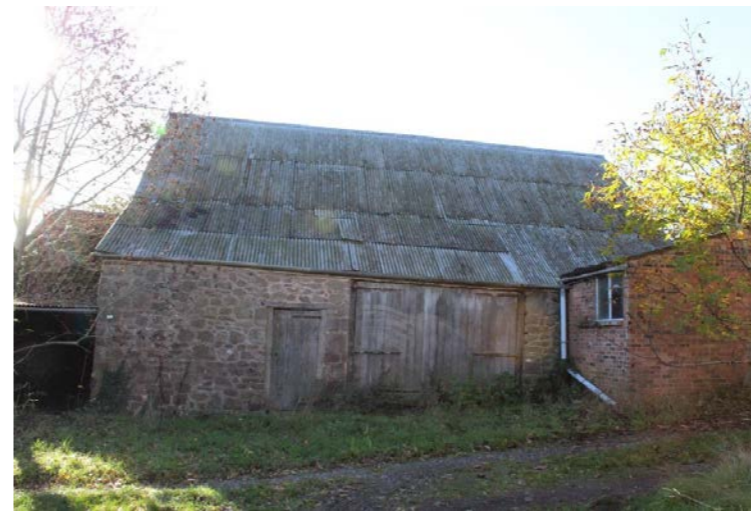
Fig. 2 Rear elevation - is in fair condition

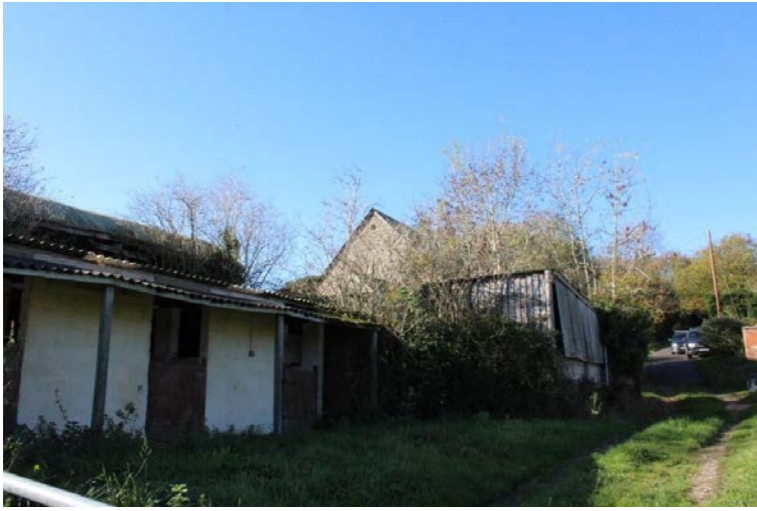
Fig. 3 Part side elevation (in background) is in fair condition

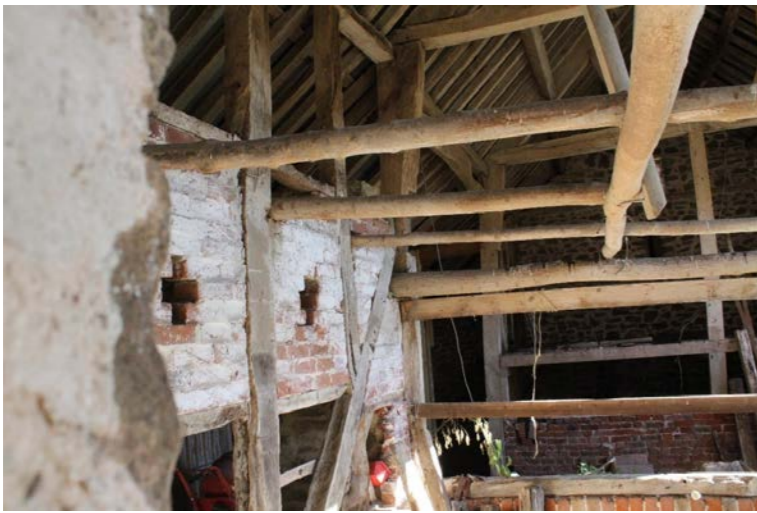
Fig. 4 Internal photo of barn viewed through a narrow wall opening - roof and wall structures appear in a stable condition

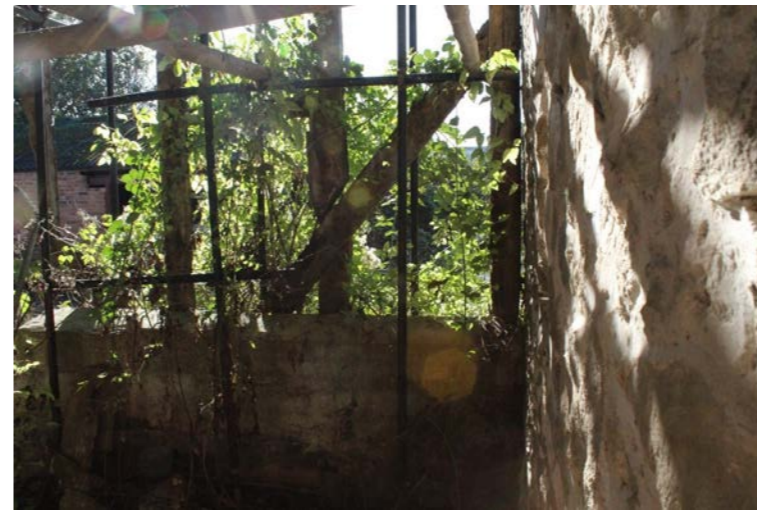
Fig. 5 Internal photo of barn viewed through a narrow wall opening - the original timber frame is on the left with brick infill panels removed. This elevation is open to the elements causing deterioration to the remaining building fabric.

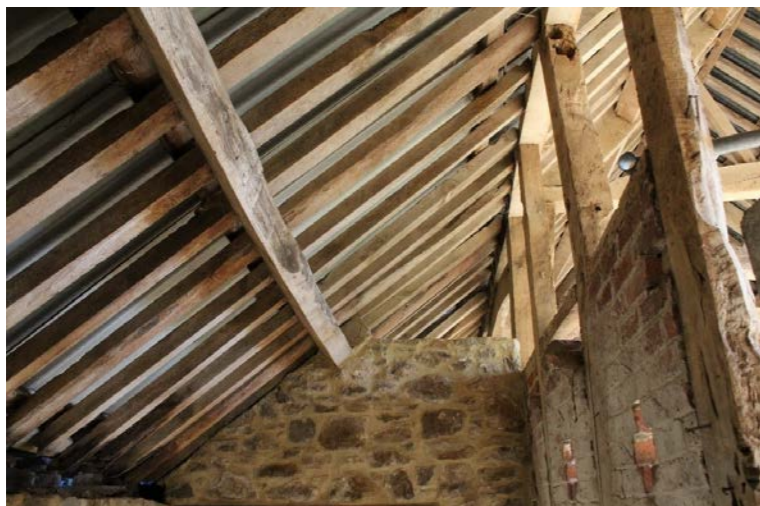
Fig. 6 Internal photo of barn viewed through a narrow wall opening - roof and walls structures appear in a stable condition

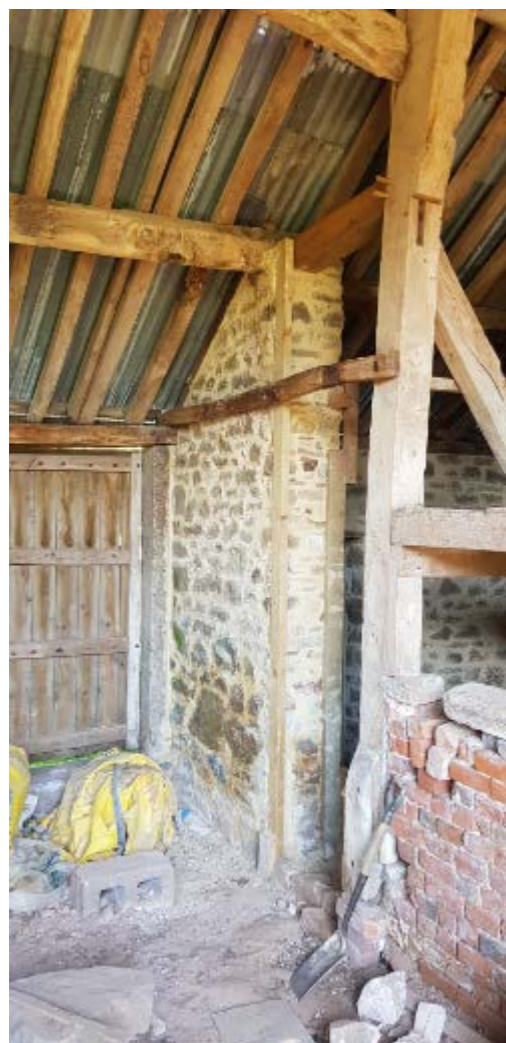
Recommendations/Actions: Although the building appears to be generally in fair condition, the conversion works are on stop and the front elevation is open to the elements causing decay, deterioration and loss of the remaining historic fabric.

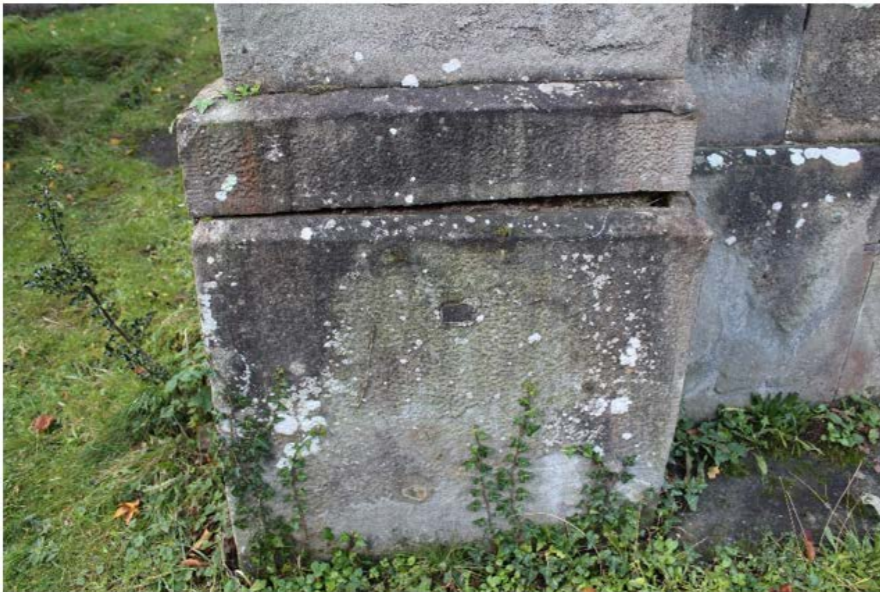
Fig.7 External stonework is defective

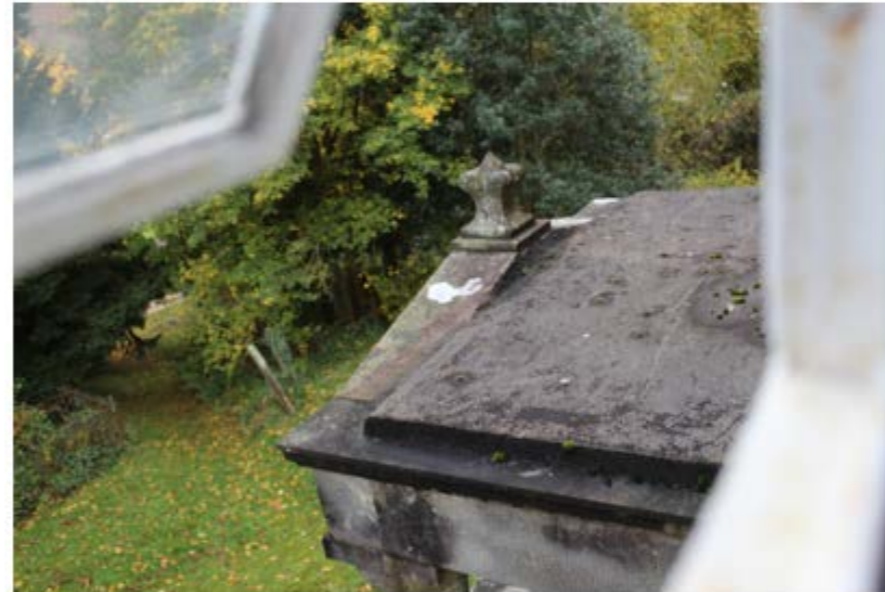
Fig.8 Front porch roof has no weather protection
