1 . Buildings at Risk

1 Buildings at Risk

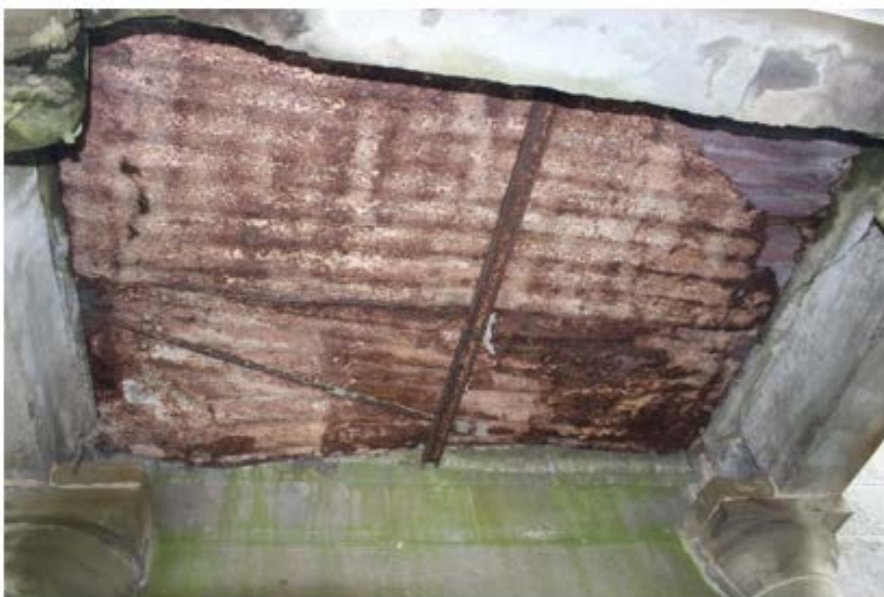
Fig. 9 Front porch roof soffit is deteriorating

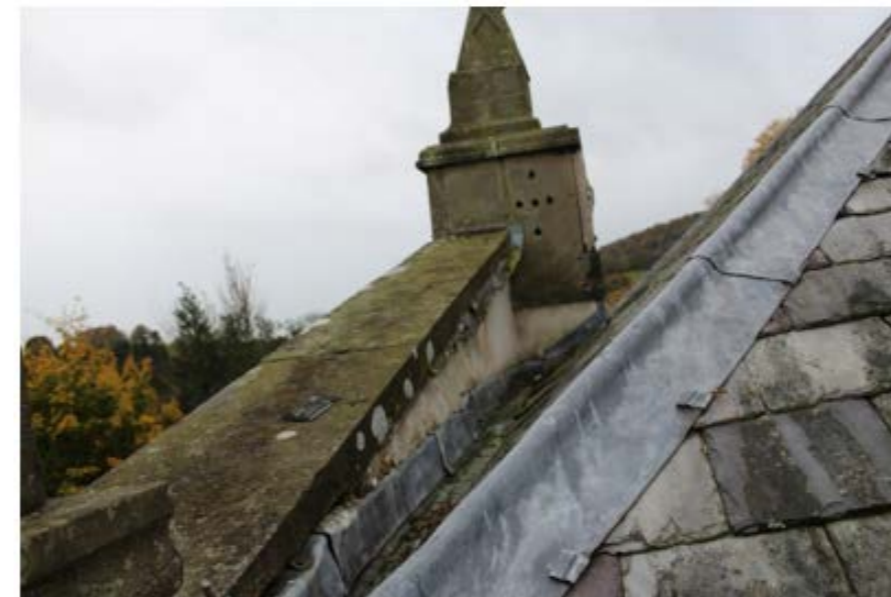
Fig. 10 Defective parapet gutter

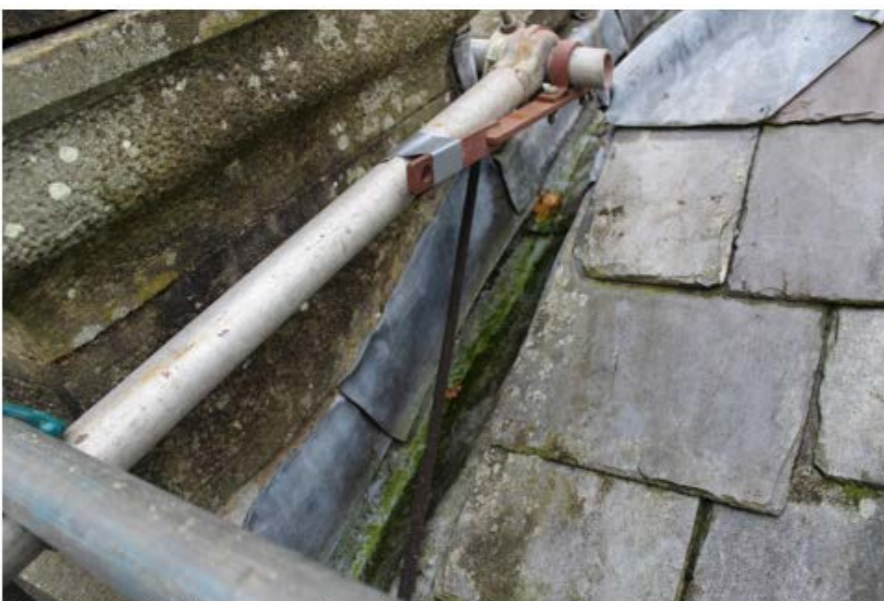
Fig.11 Defective parapet gutter is allowing ingress of water into the building

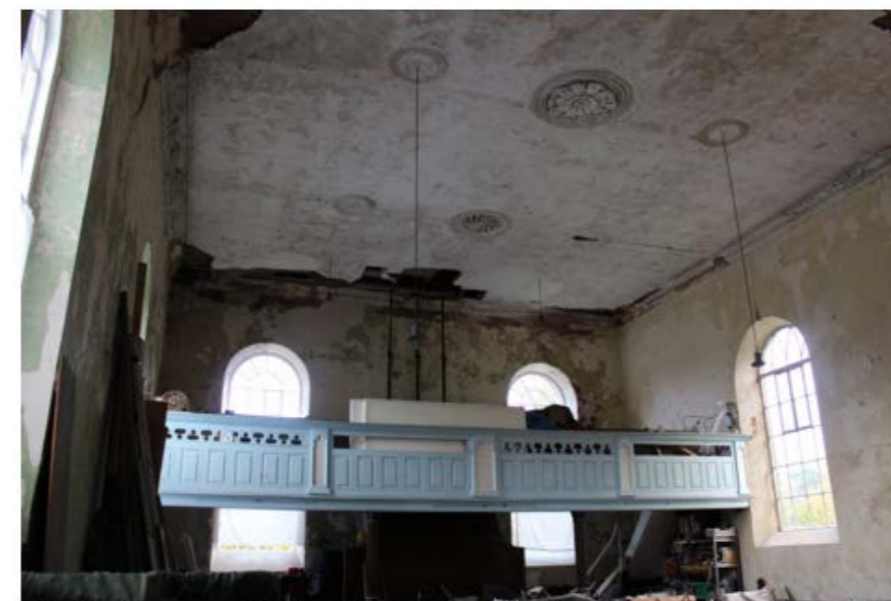
Fig. 12 Ingress of water has caused partial collapse of main ceiling finishes

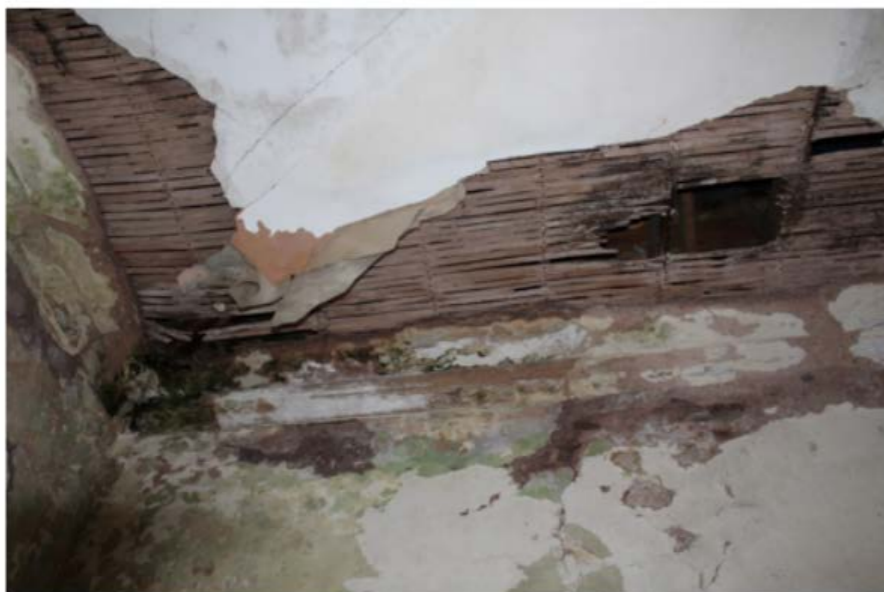
Fig. 13 Ingress of water has caused partial collapse of main ceiling finishes

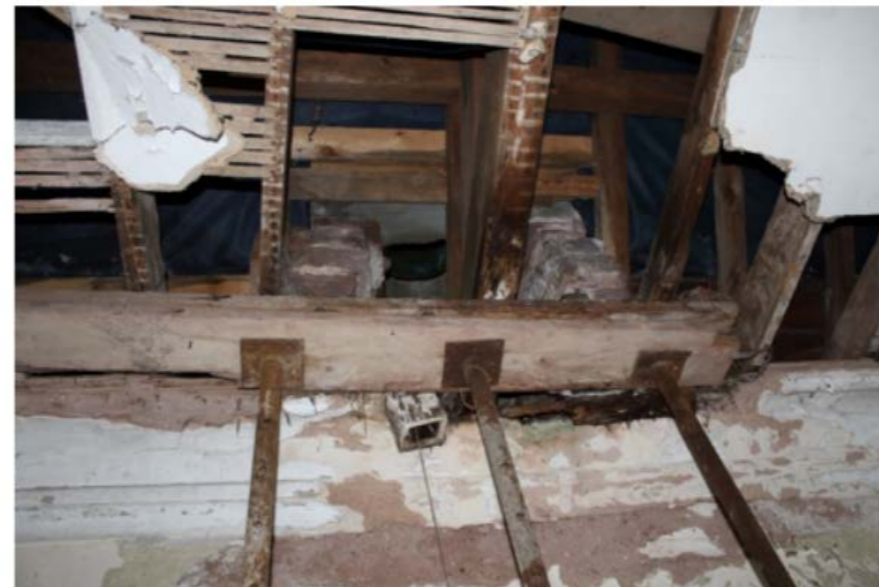
Fig. 14 Temporary propping of main ceiling structure

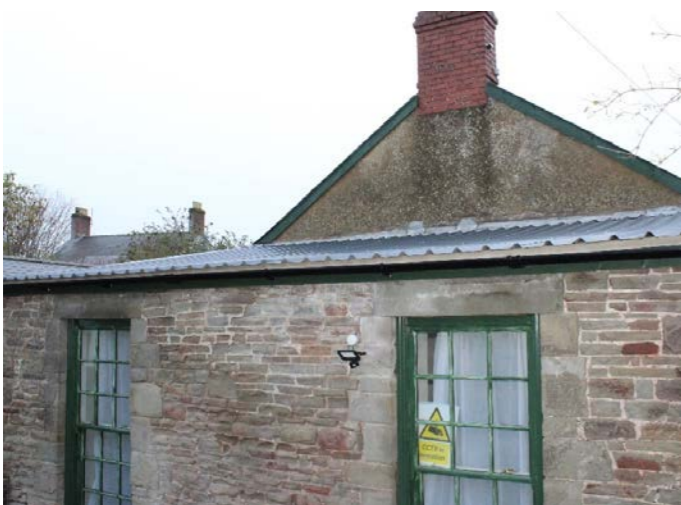
Fig. 5 Part rear elevation - lean too roof coverings recently replaced

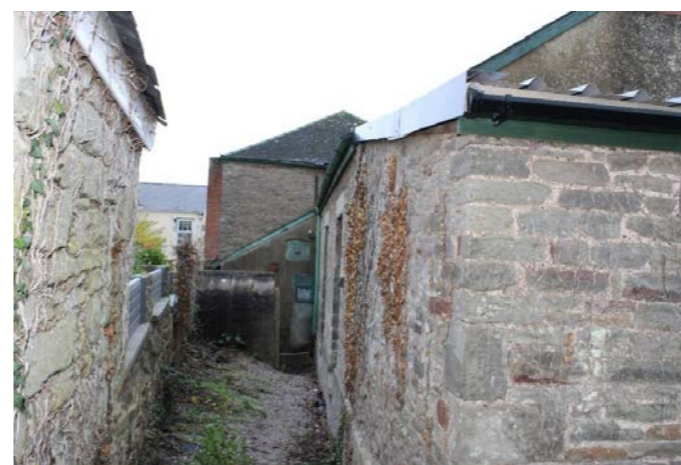
Fig. 6 Part rear elevation

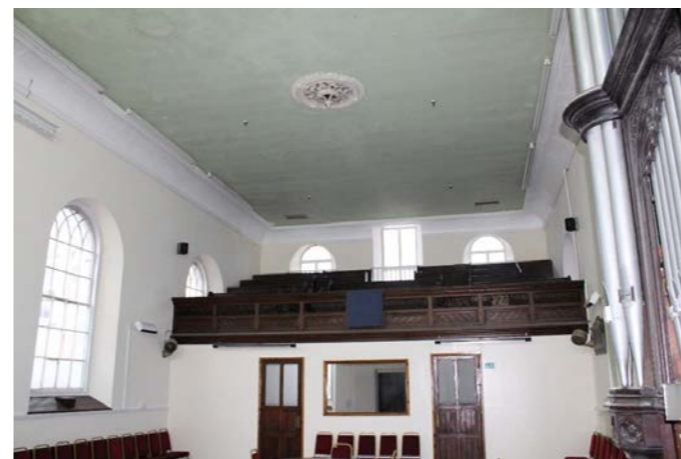
Fig.12 Internal view of Nave - has been recently repainted

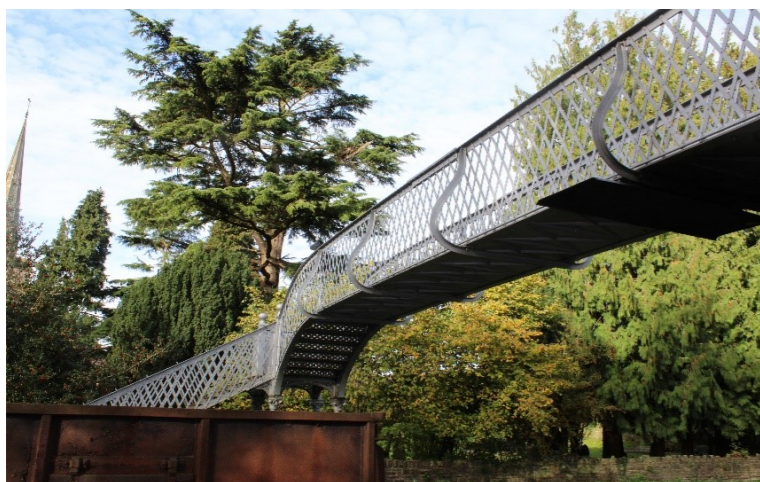
17 . The Footbridge at St Mary's Halt, Lydney

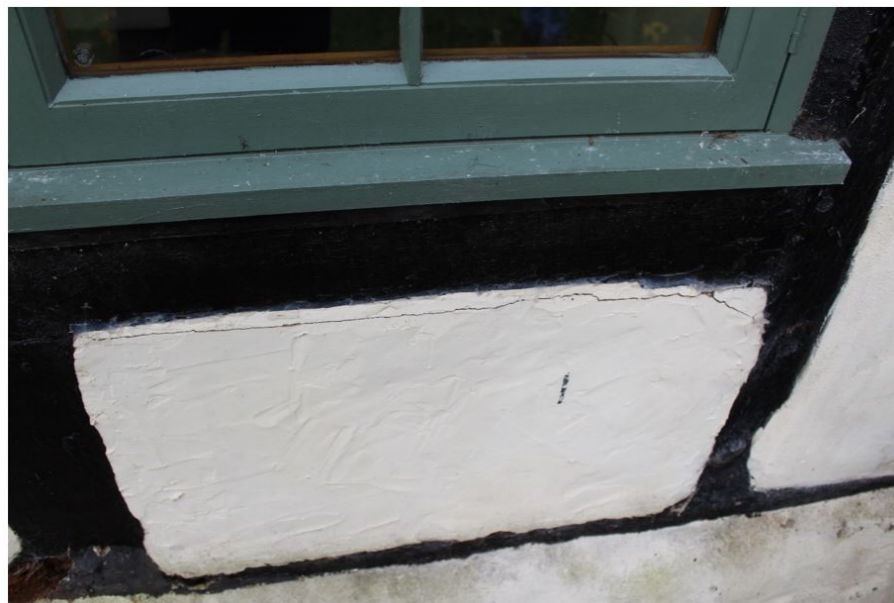
Fig. 5 Modern hard impervious renders and paints applied to external panels are trapping moisture

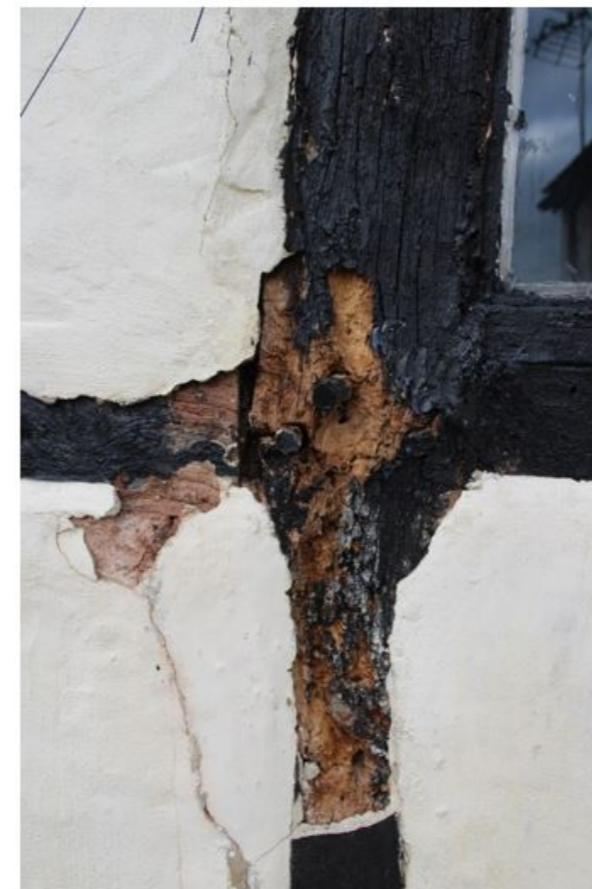
Fig 6. Trapped moisture is causing harmful decay of the original external timber frame

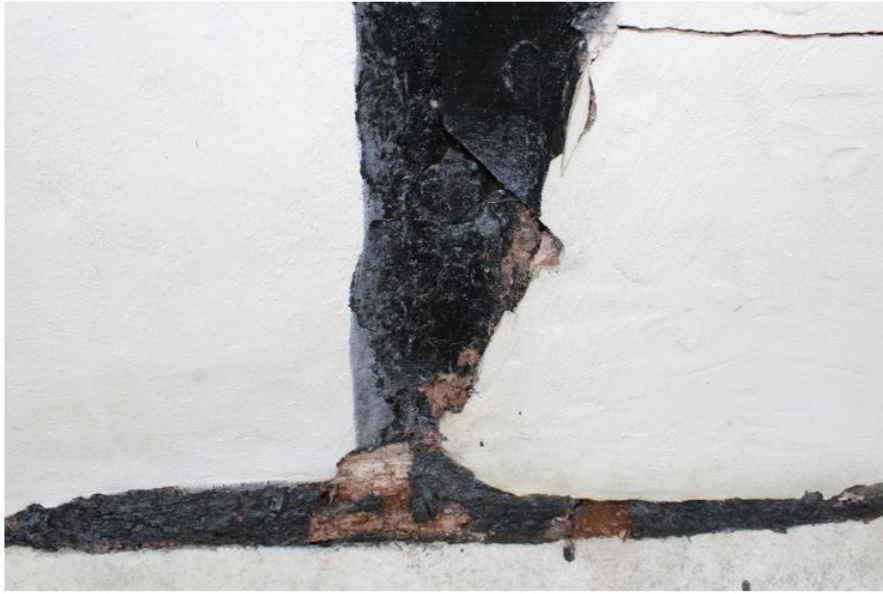
Fig.7 Trapped moisture is causing harmful decay of the original external timber frame

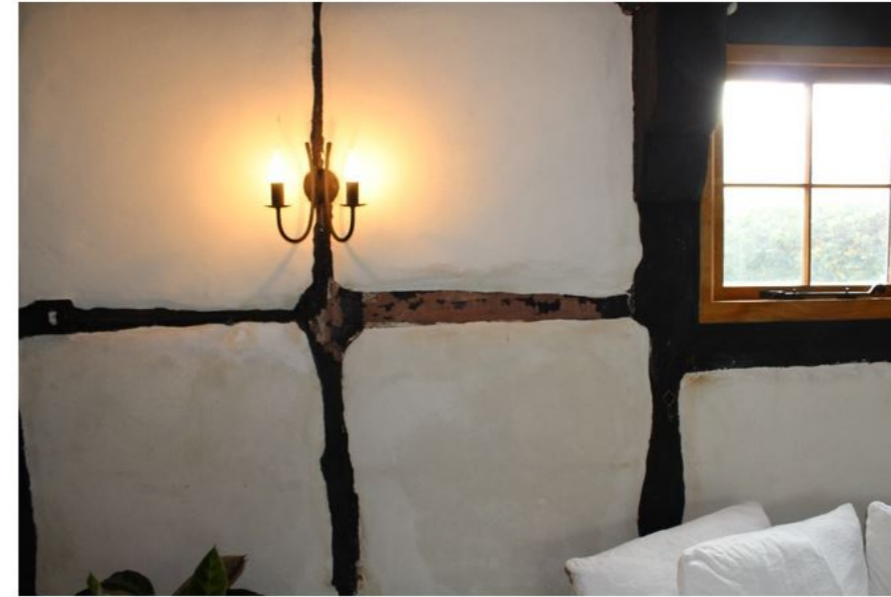
Fig.8 Trapped moisture is causing harmful decay of the original internal timber frame

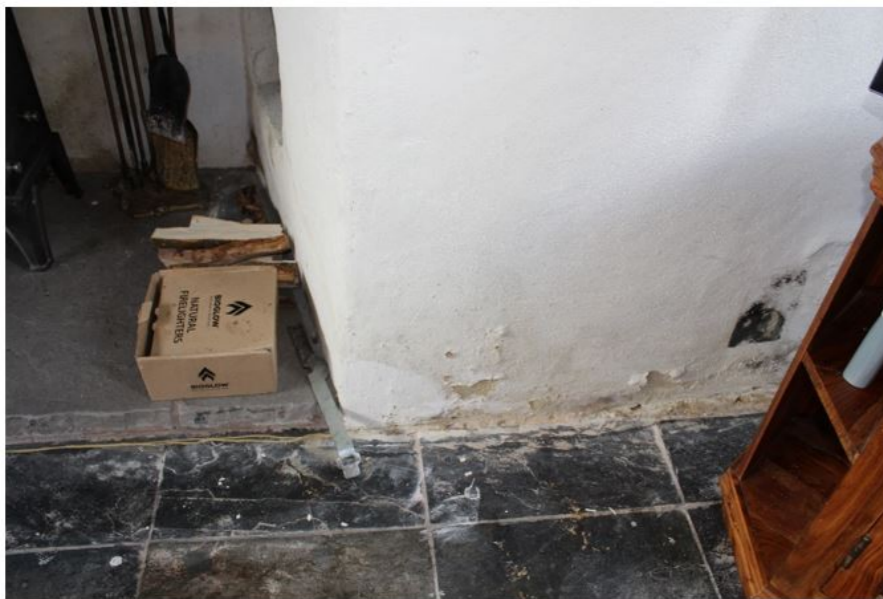
Fig.9 Modern hard impervious plasters and paints applied to internal walls are trapping moisture and causing decay

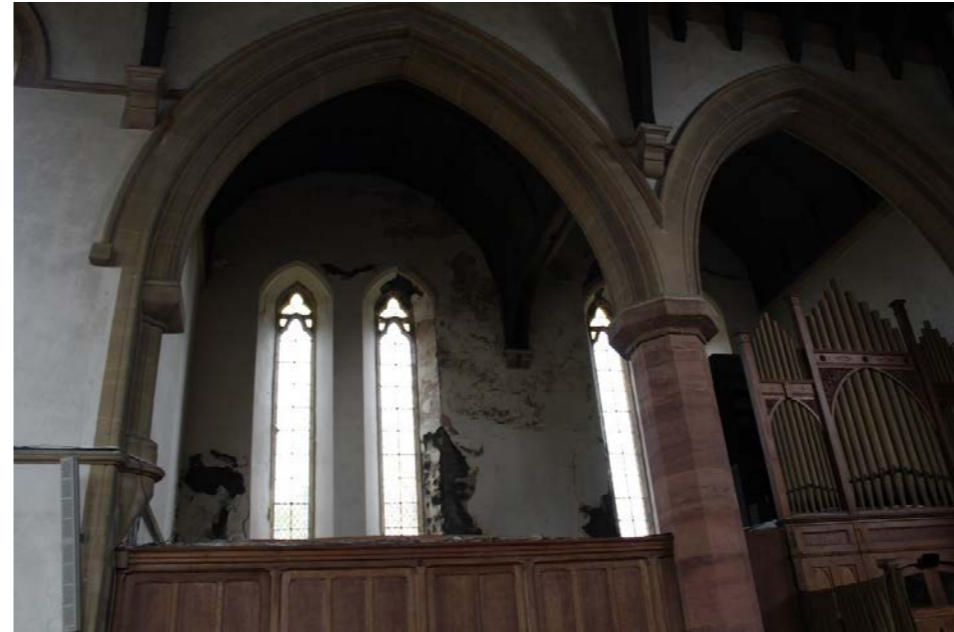
Fig. 8 Internal Damage

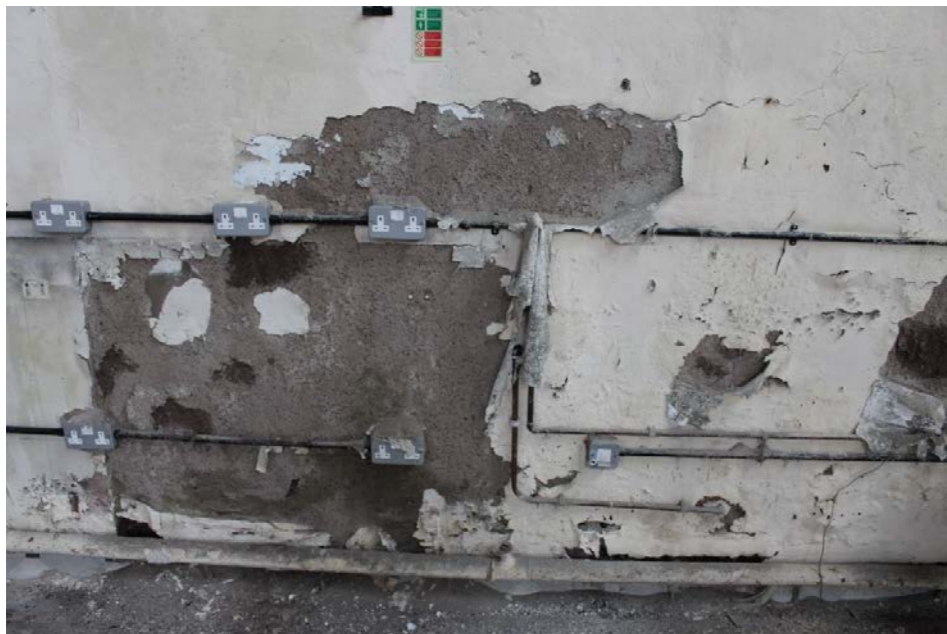
Fig.9 Internal Damage

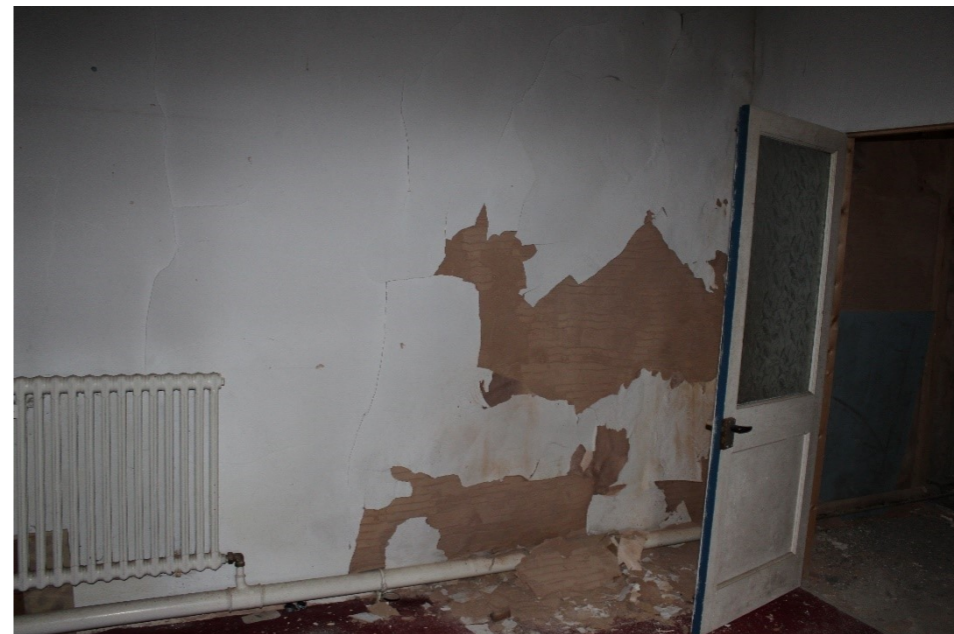
Fig. 10 Internal Damage

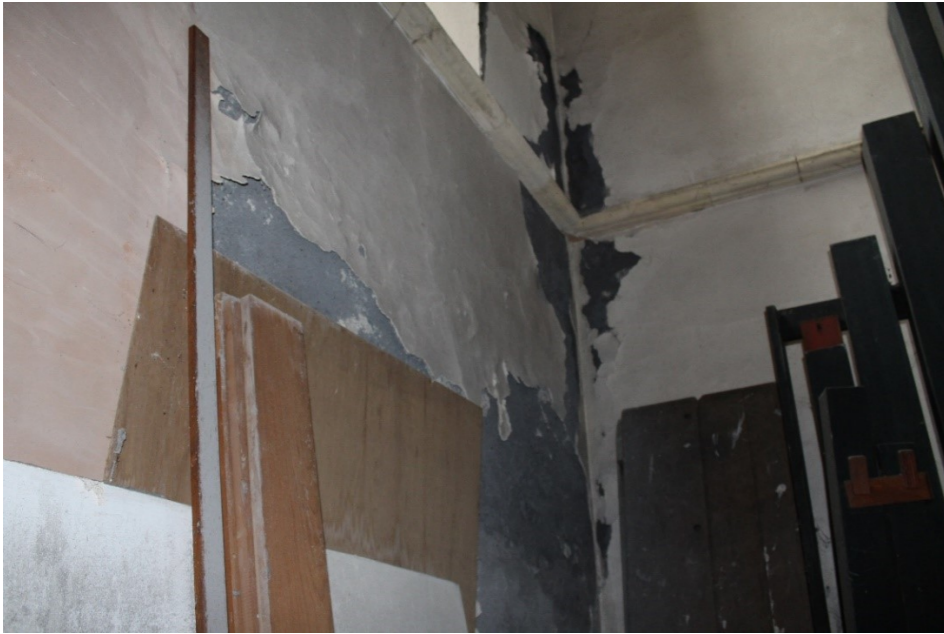
Fig. 11 Internal Damage

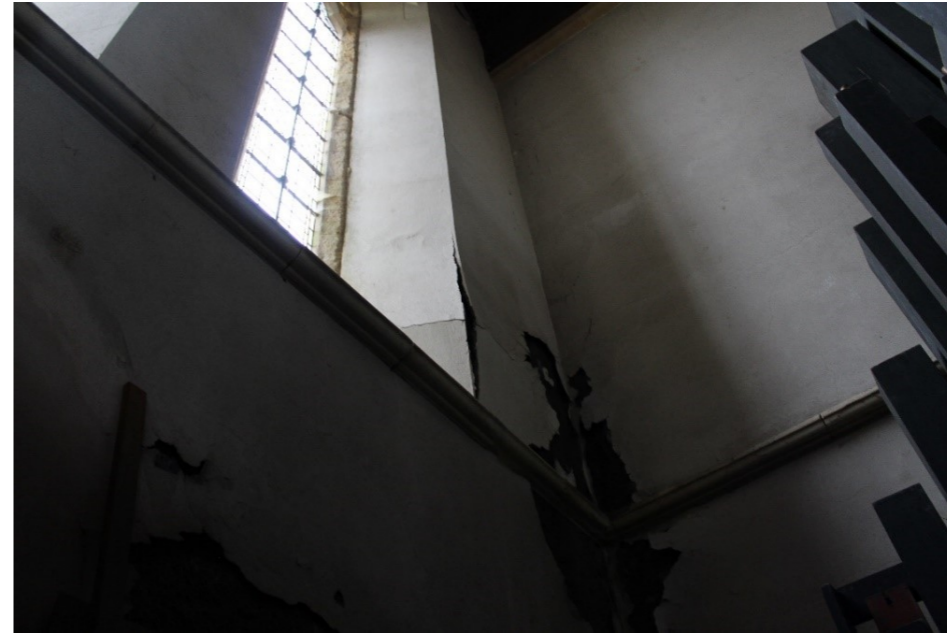
Fig.12 Internal Damage

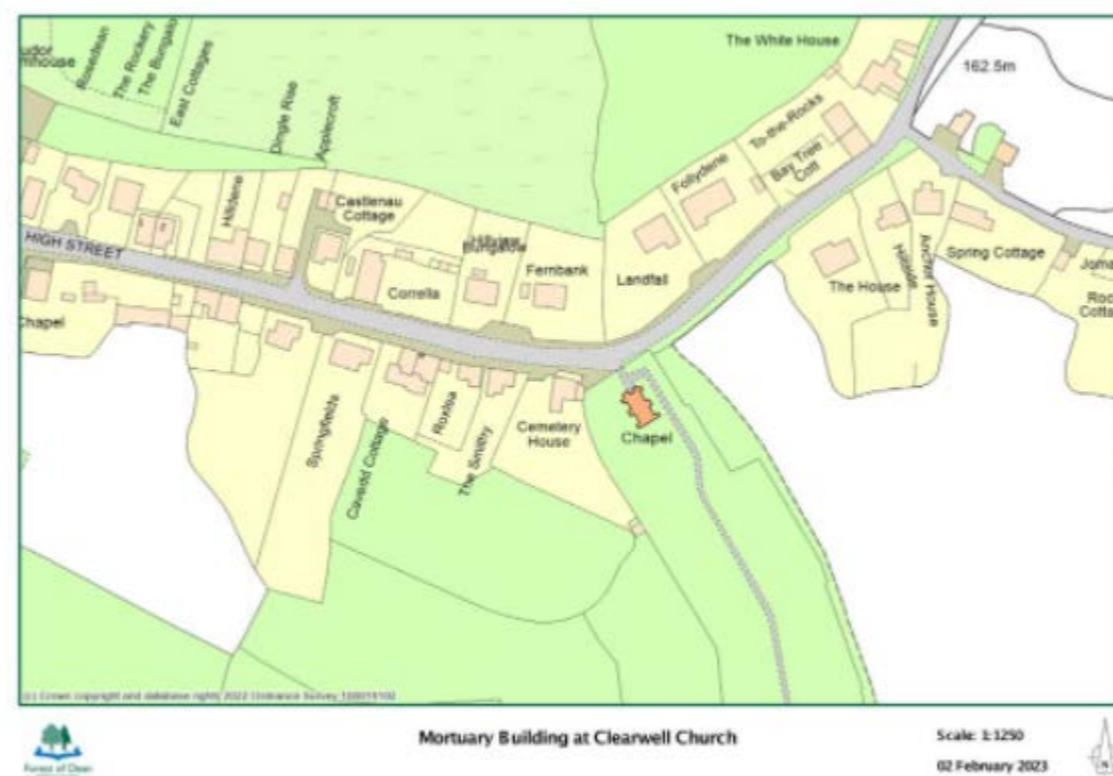
Description: Mortuary Chapel. 1867 by John Middleton, architect of Church of St. Peter (q.v.). Squared snecked rubble stone with Bath stone dressings, tile roof. Bellcote to north with large rose window below and elaborate carved doorway. Interior plain single cell with unplastered walls and 2 single lancets on each side. Scissor beam roof.

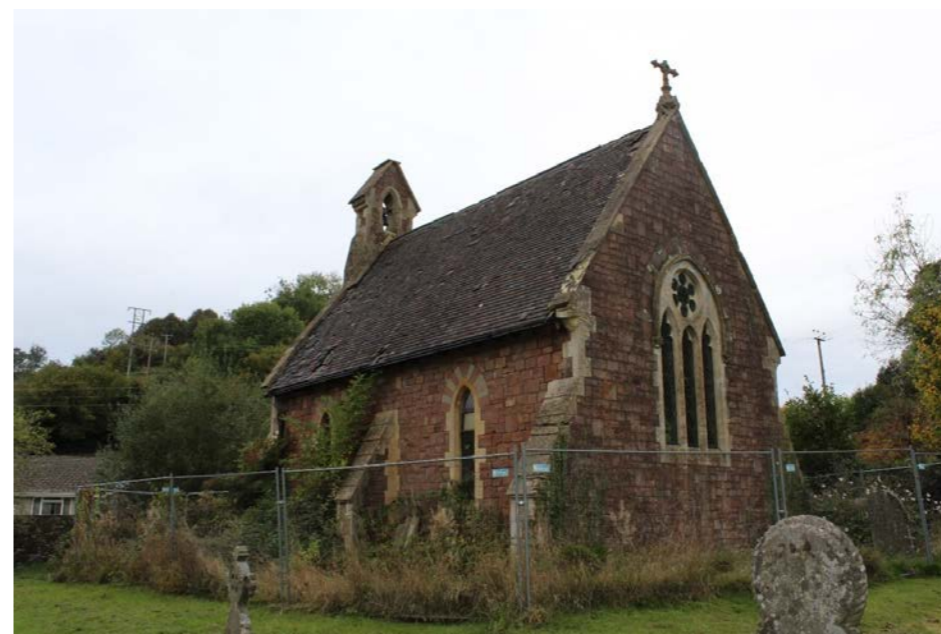
Fig.2 Rear/side elevation

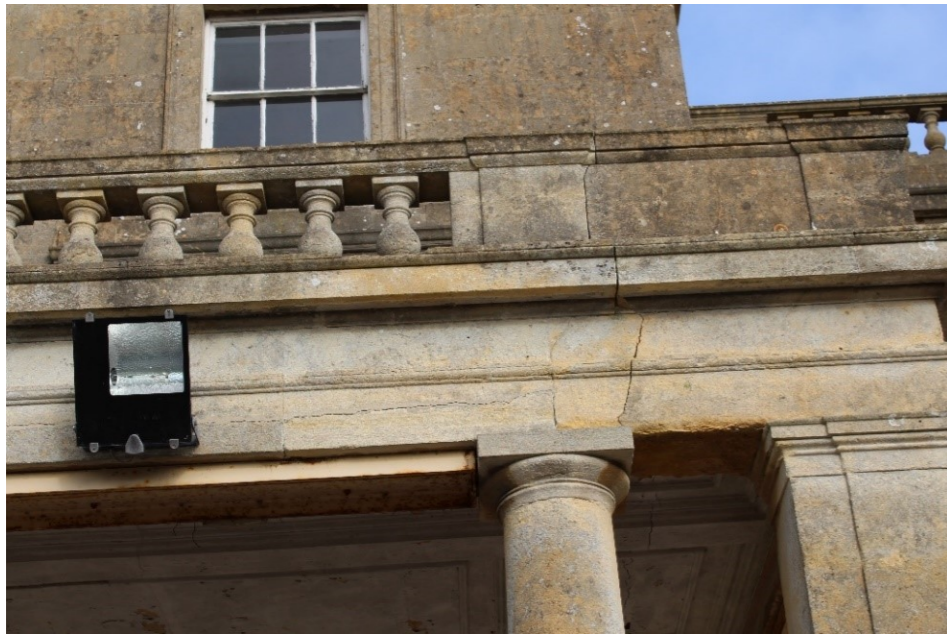
Fig.3 Front porch - cracking evident in stonework

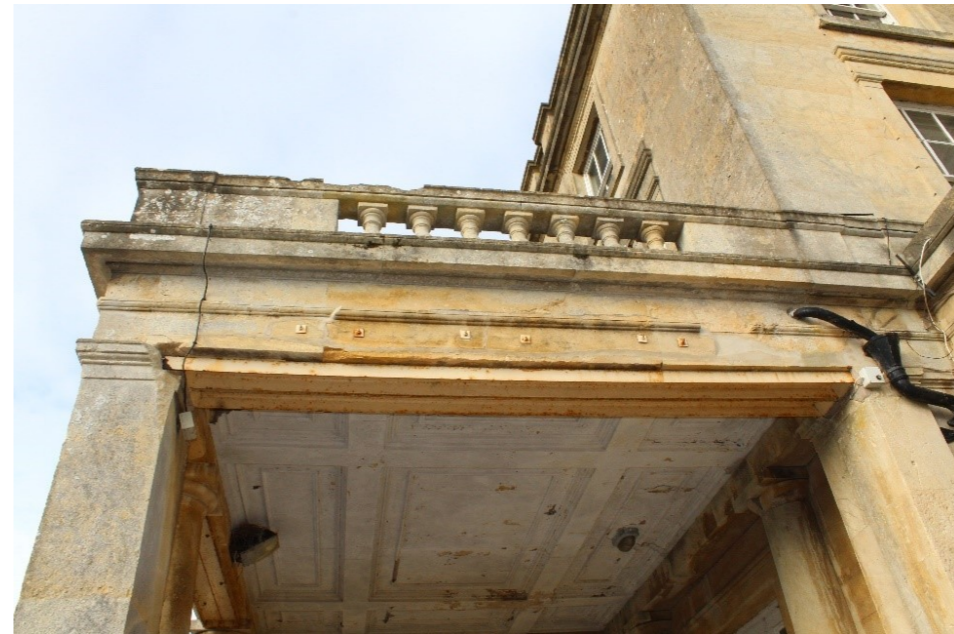
Fig. 4 Front porch - corrosion of exposed steel beam supports

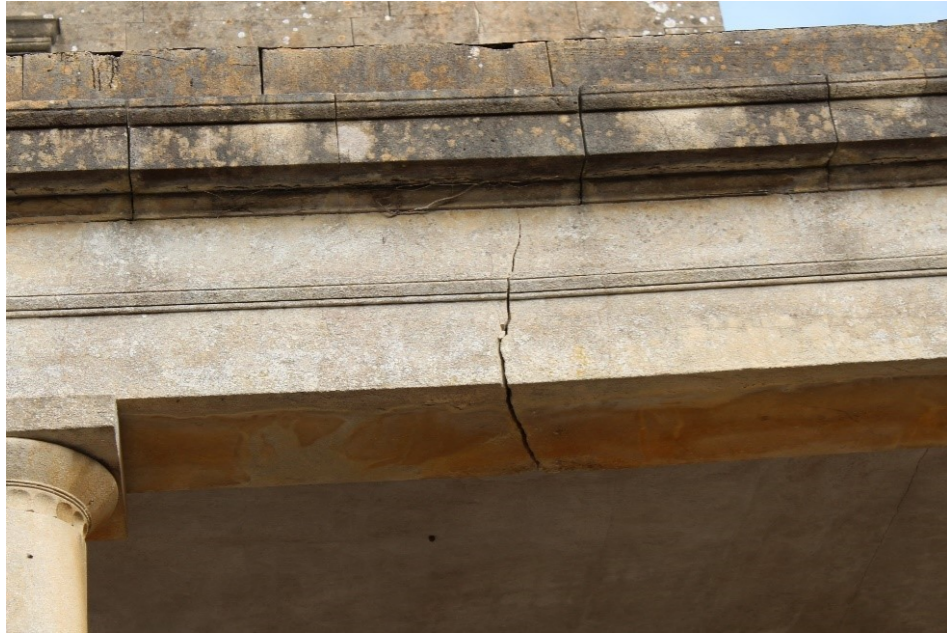
Fig. 5 Front colonnade - cracking evident in stonework

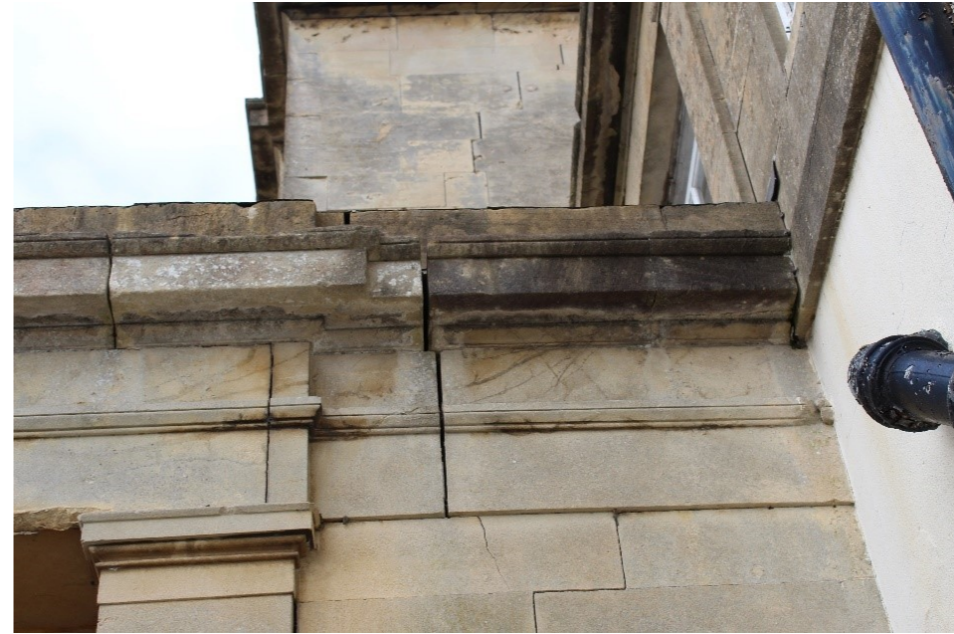
Fig. 6 Side of colonnade - cracking evident in stonework

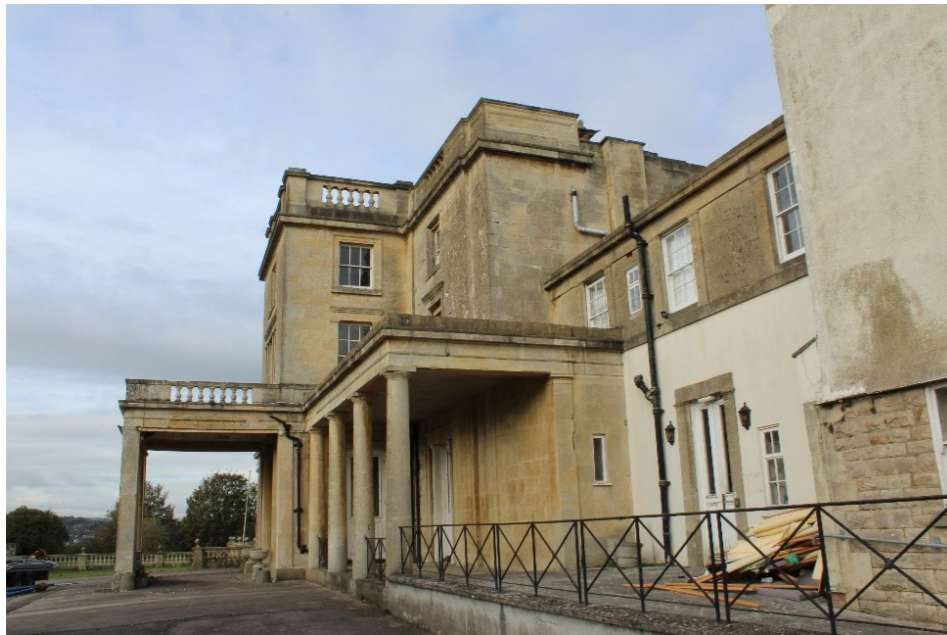
Fig. 7 Part side elevation

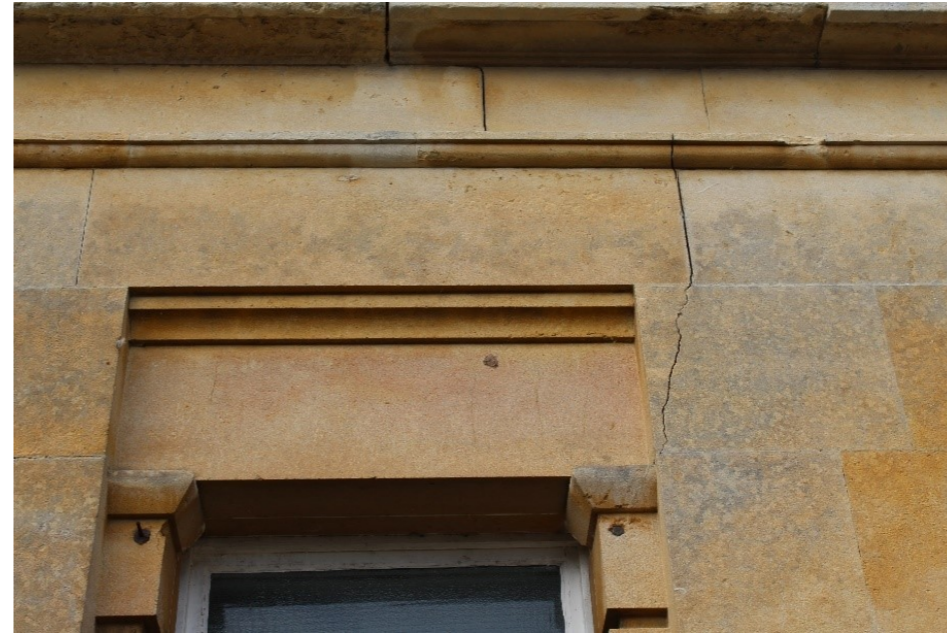
Fig. 10 Rear elevation - cracking evident in stonework

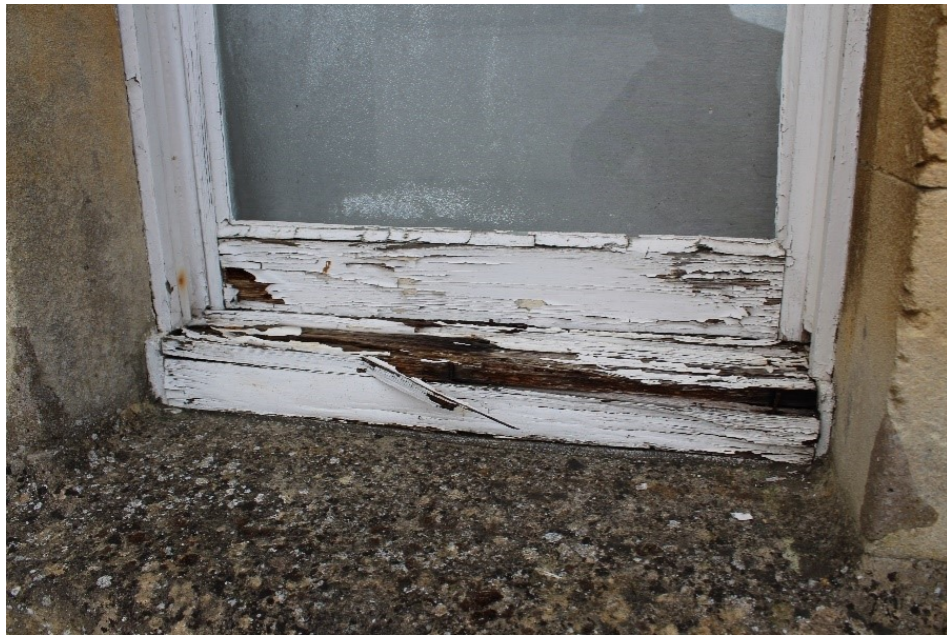
Fig. 11 Defective timber windows

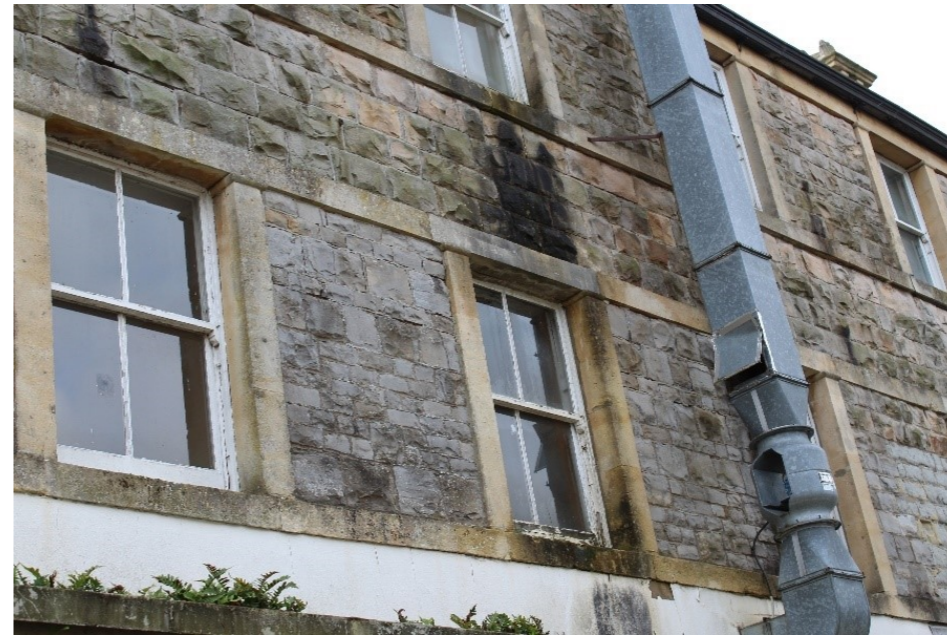
Fig. 12 Defective timber windows

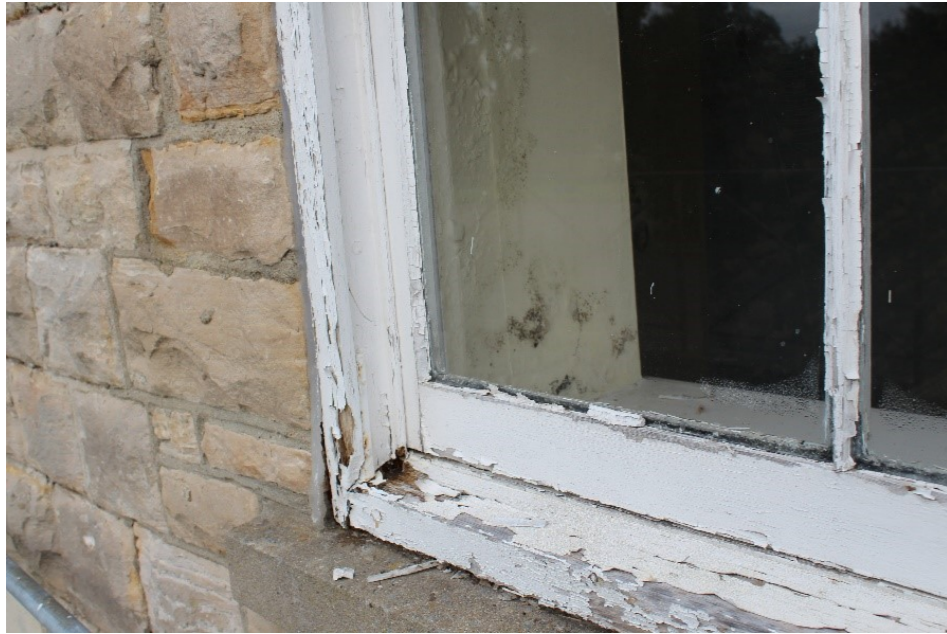
Fig. 13 Defective timber windows

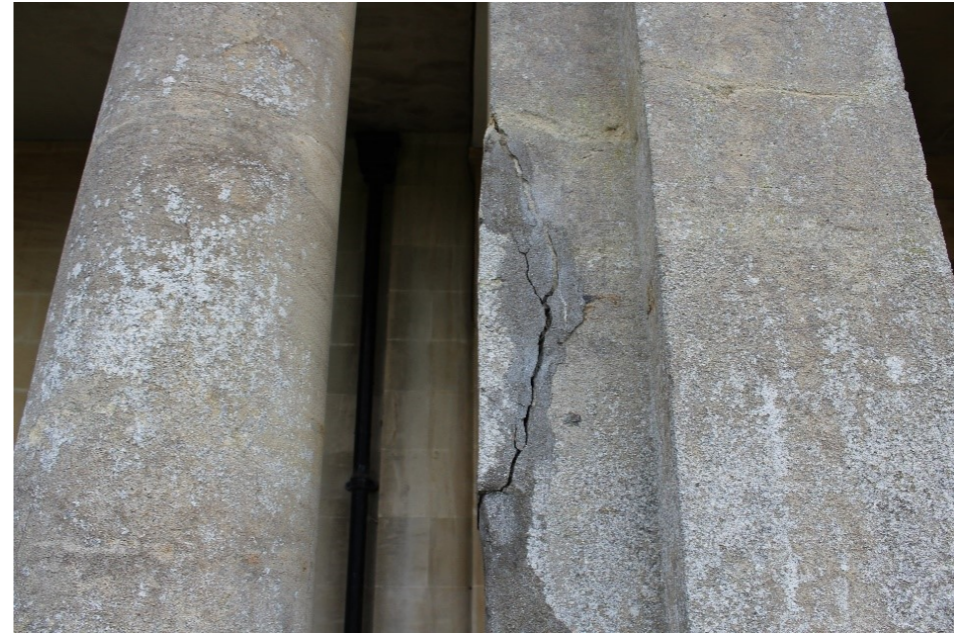
Fig. 14 Corrosion of steel work is cracking masonry walls

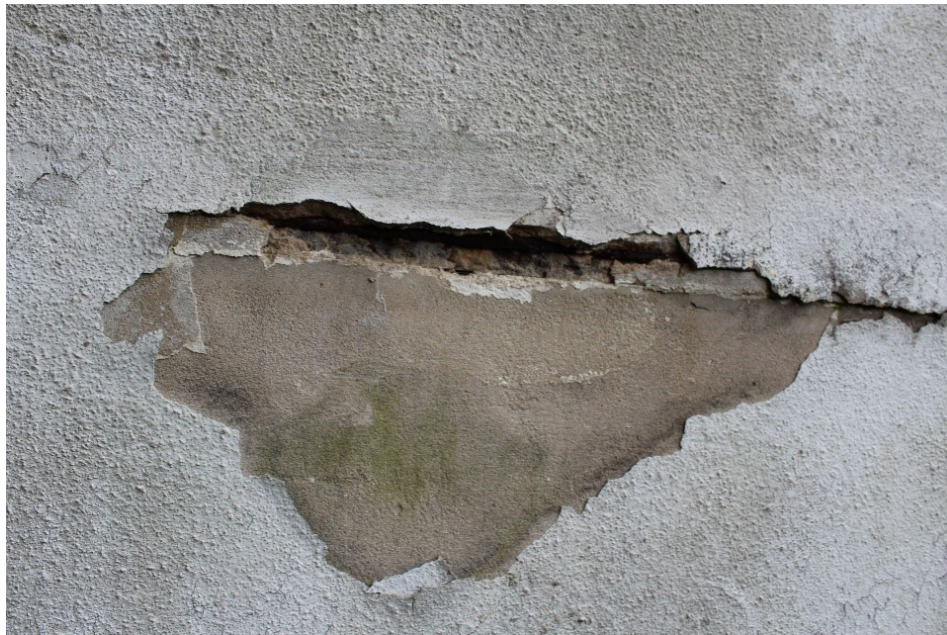
Fig. 15 Corrosion of steel work is cracking masonry walls

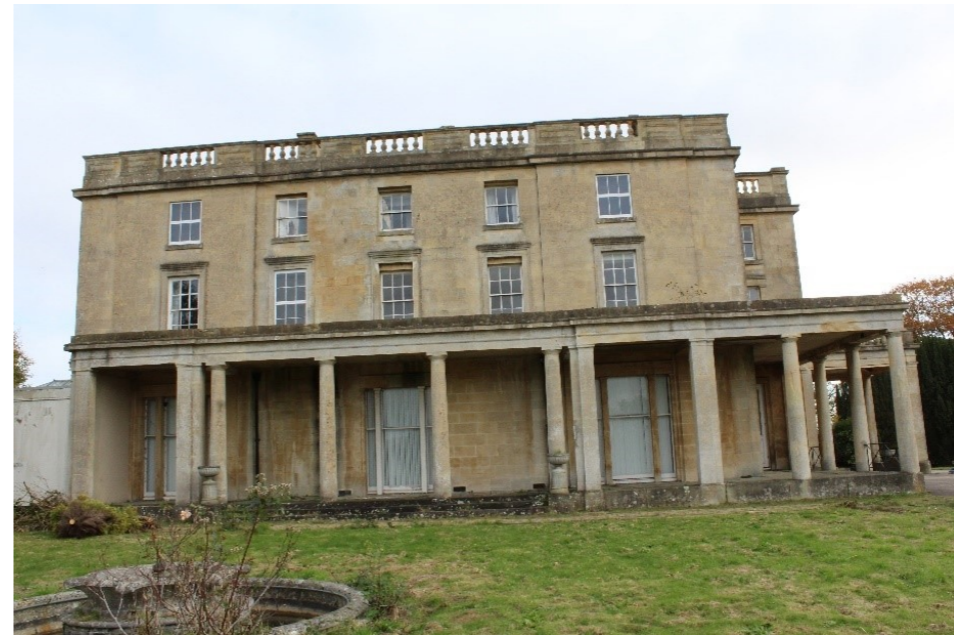
Fig. 16 Side elevation

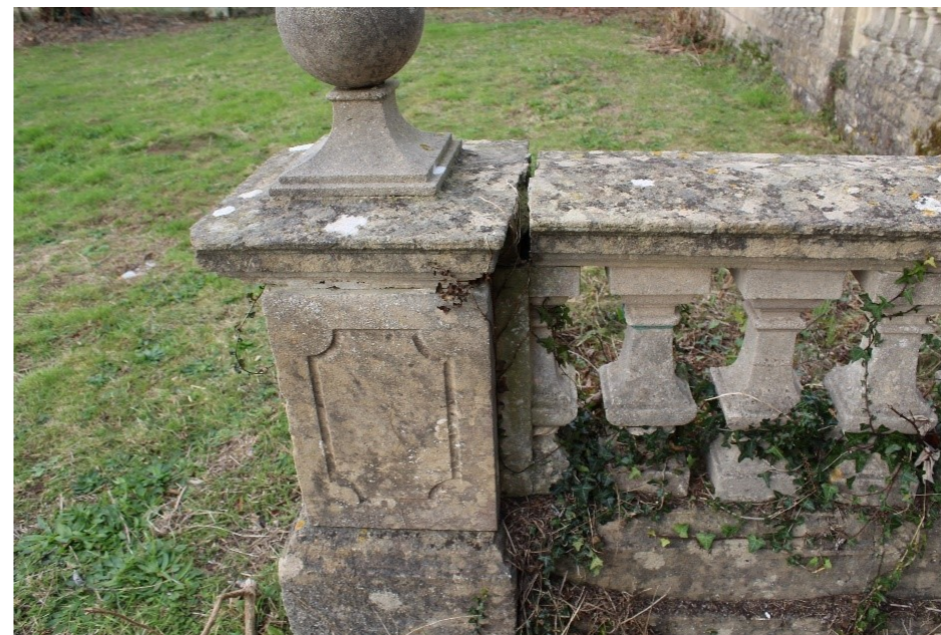
Fig. 18 Cracking evident in stonework

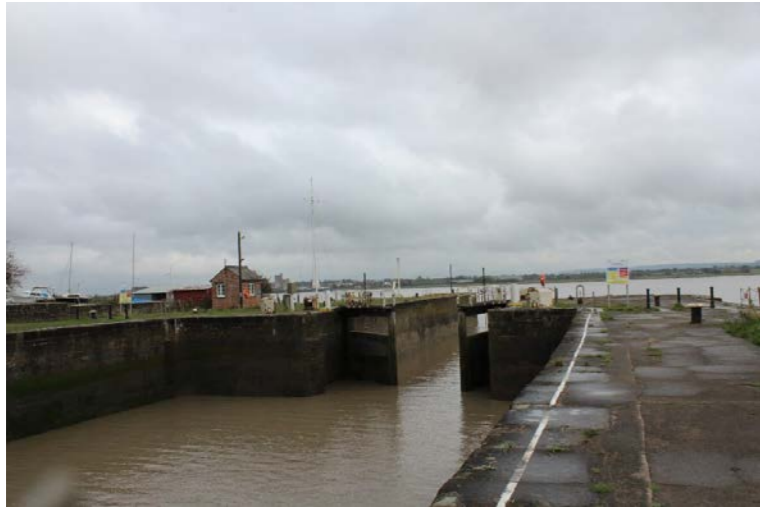
Fig.1 North and south pier and lock gate require repair. Harbourmasters building (on left) has been restored.

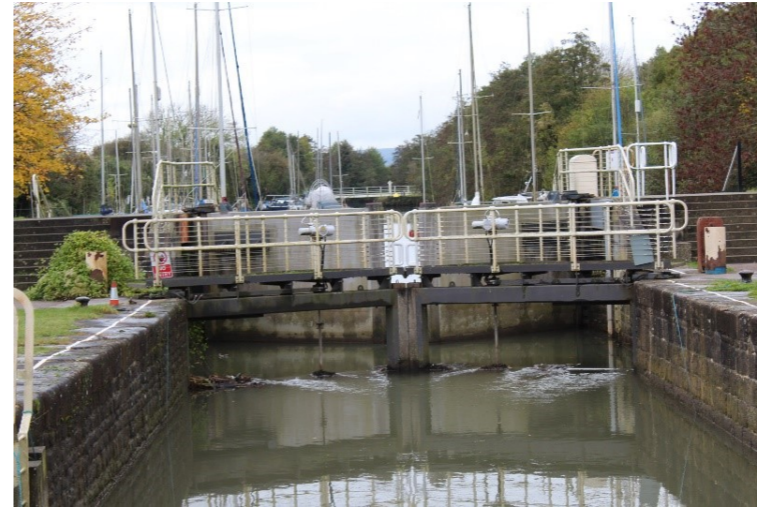
Fig.2 Lock gate and tidal exclusion gate require repair.

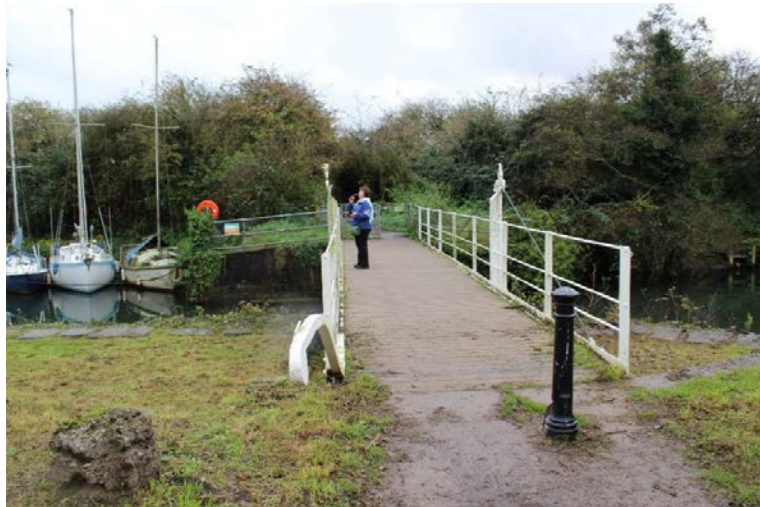
Fig.3 Swing Bridge requires repairs to operate again.

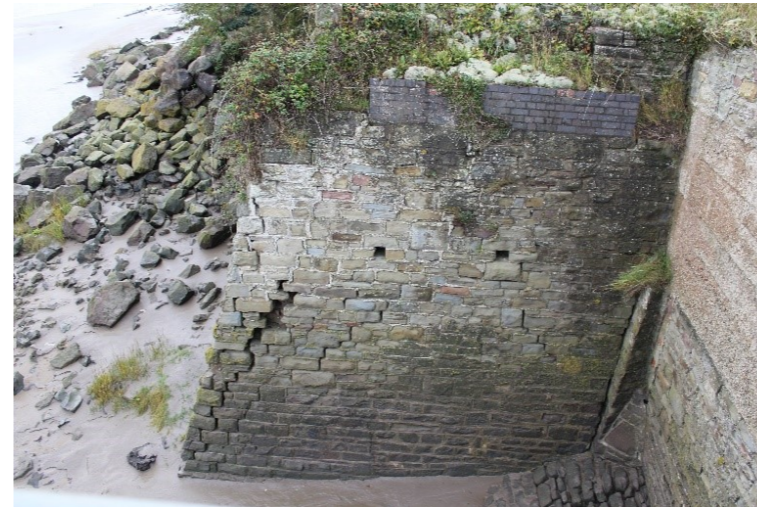
Fig.4 Defective stonework to sluice outfall requires repair.

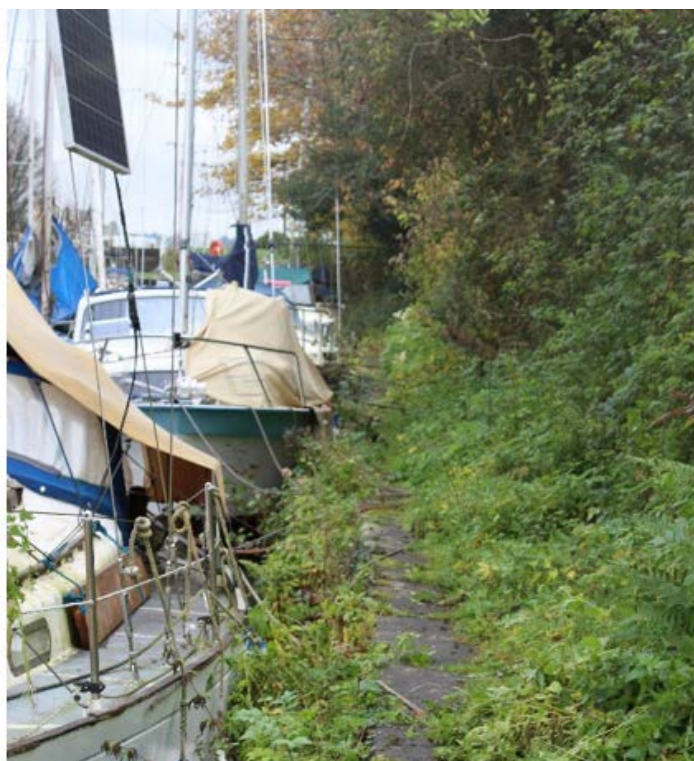
Fig.5 Moorings require restoration.

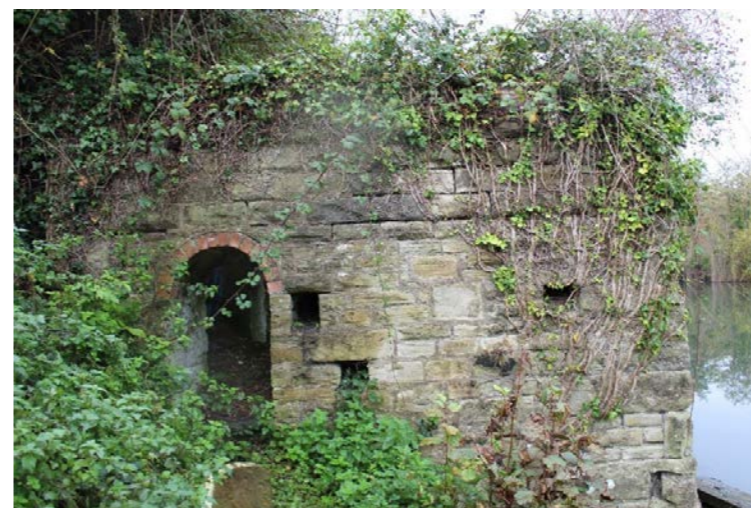
Fig.6 Railway coal chute to load boats requires repair.

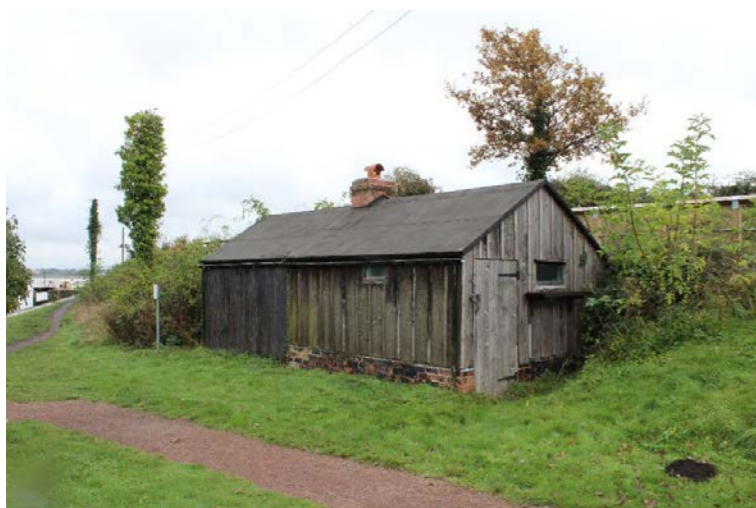
Fig.7 Generator shed and wages office requires repair.
