1 . Buildings at Risk

1 Buildings at Risk

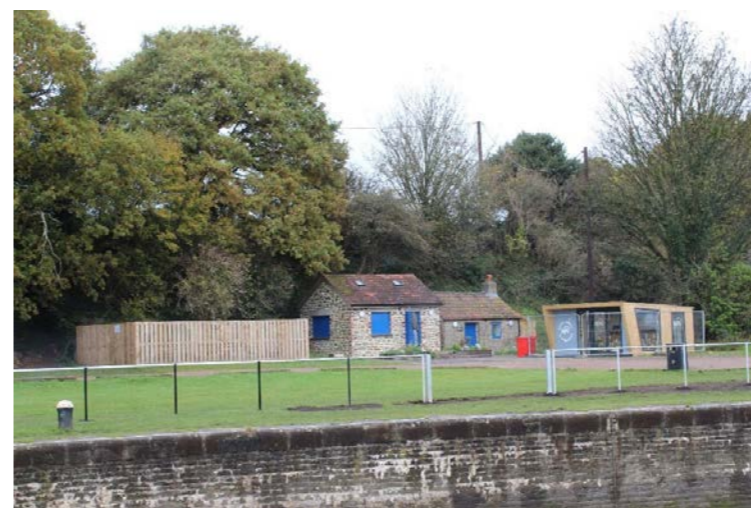
Fig.8 Restored buildings used as an accessible toilet and visitor centre with pop up café. New fencing in progress seen in foreground.

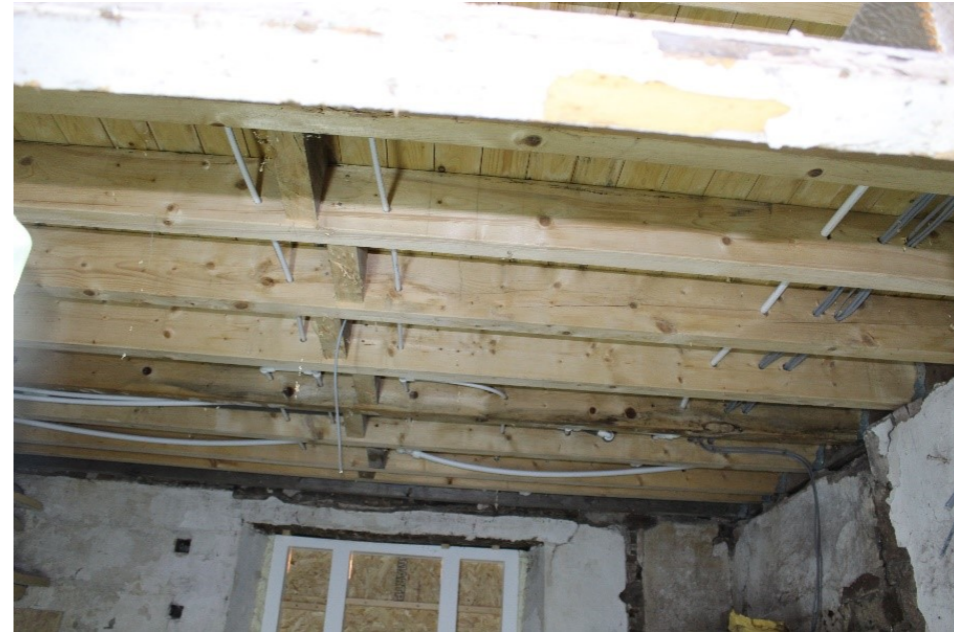
Fig. 6 Internal View - Upper Floor Repair/Replacement

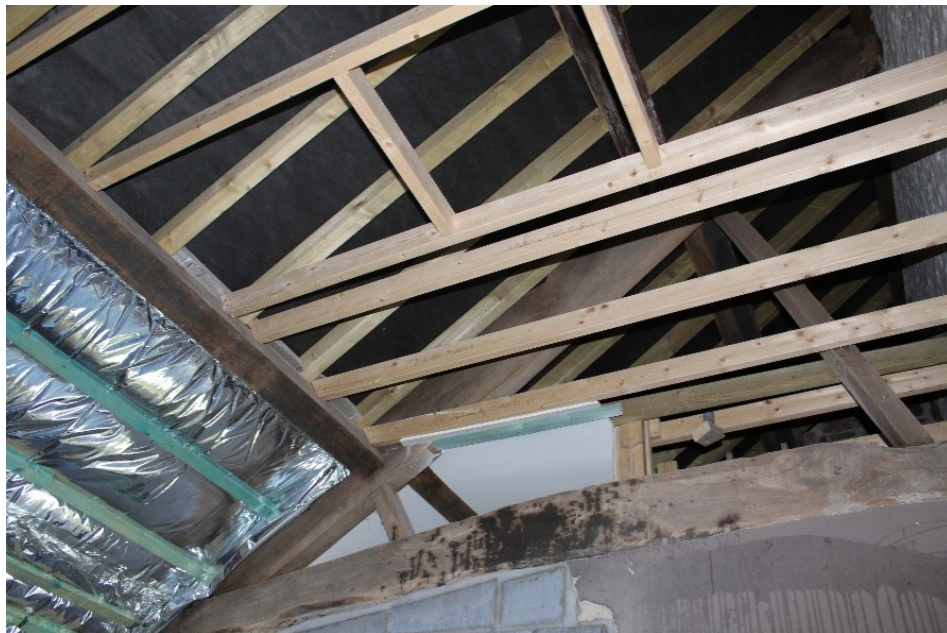
Fig.7 Internal View - Roof Repair/Replacement

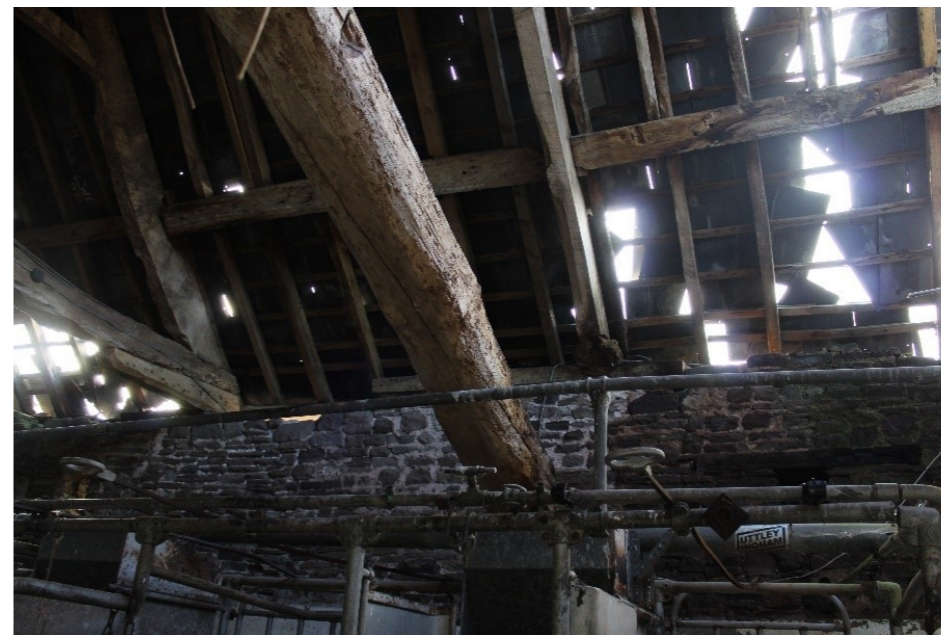
Fig.13 Internal View - Collapsed Tie Beam of Roof Truss

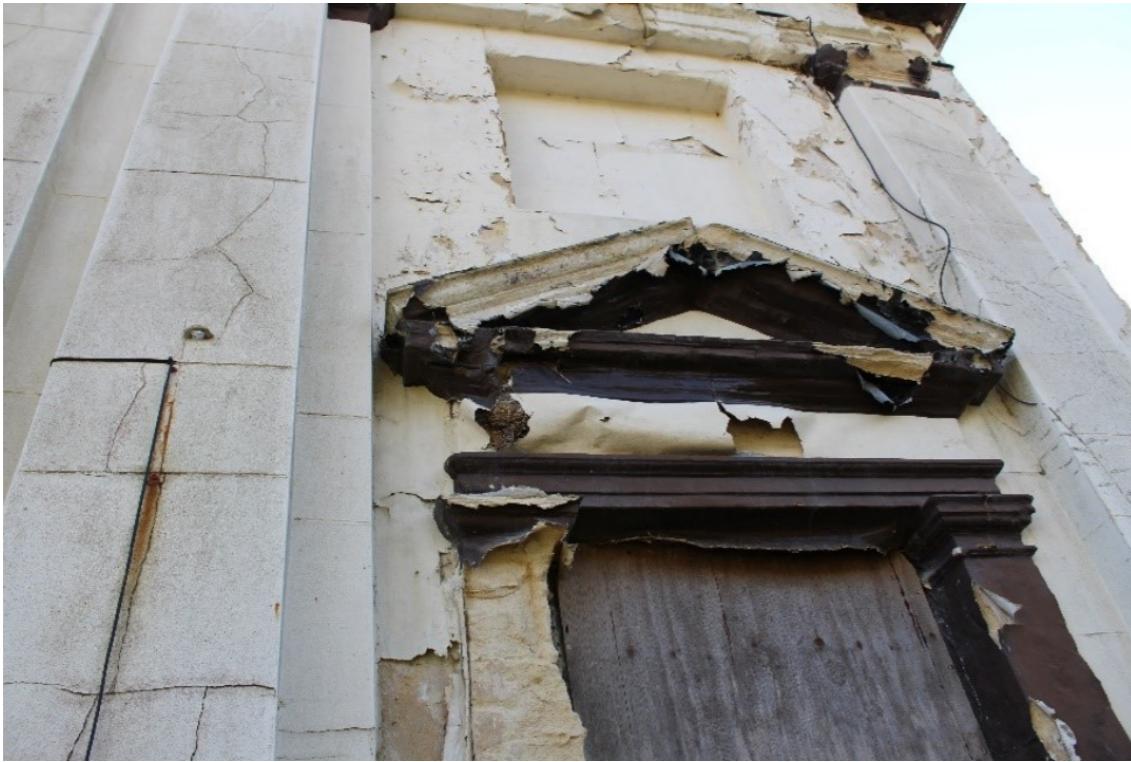
Fig.3 Inappropriate impervious render/paint applied to ornated external stonework has caused decay of the permeable stone below.

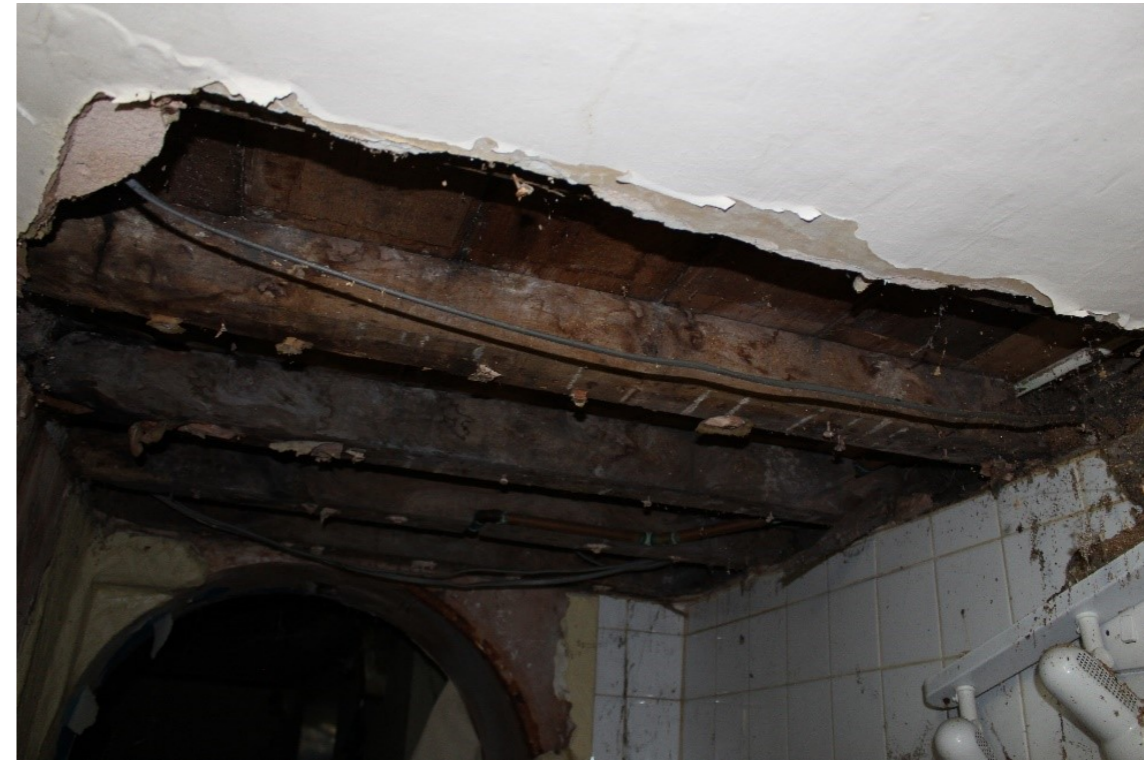
Fig. 4 Roof leaks have caused decay, collapsed and loss of the historic structure below in multiple areas over 3 floors.

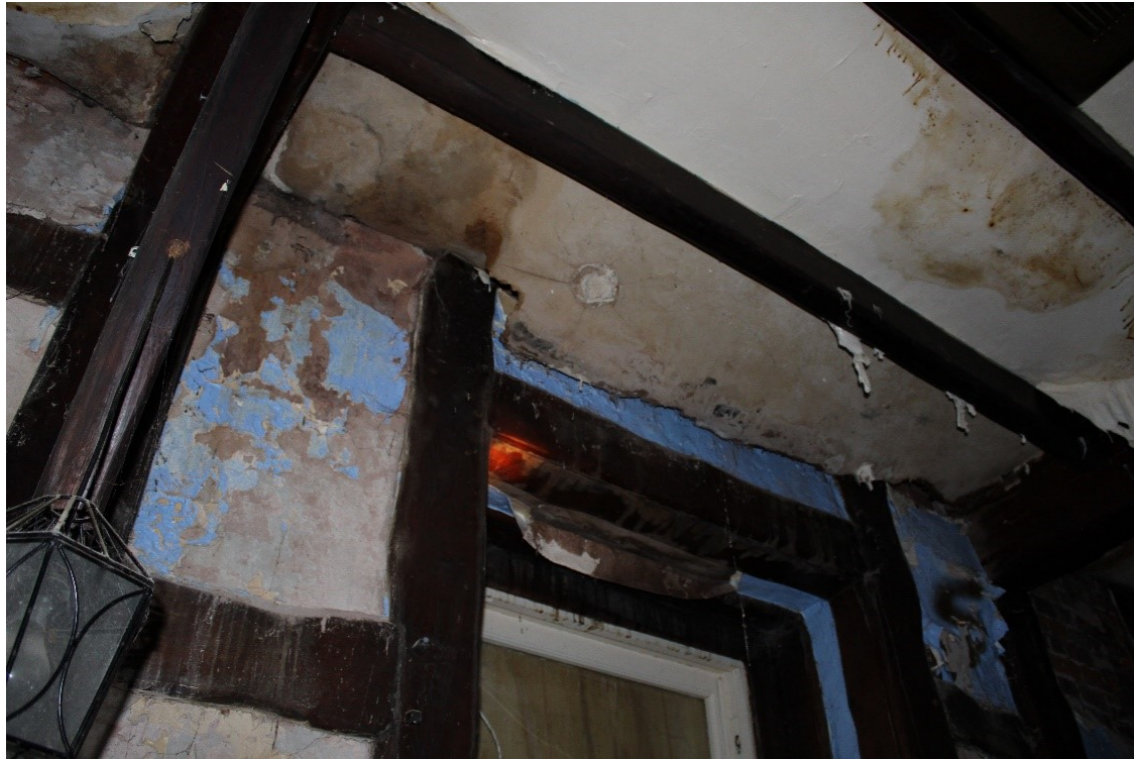
Fig. 5 Roof leaks have caused decay, collapsed and loss of the historic structure below in multiple areas over 3 floors.

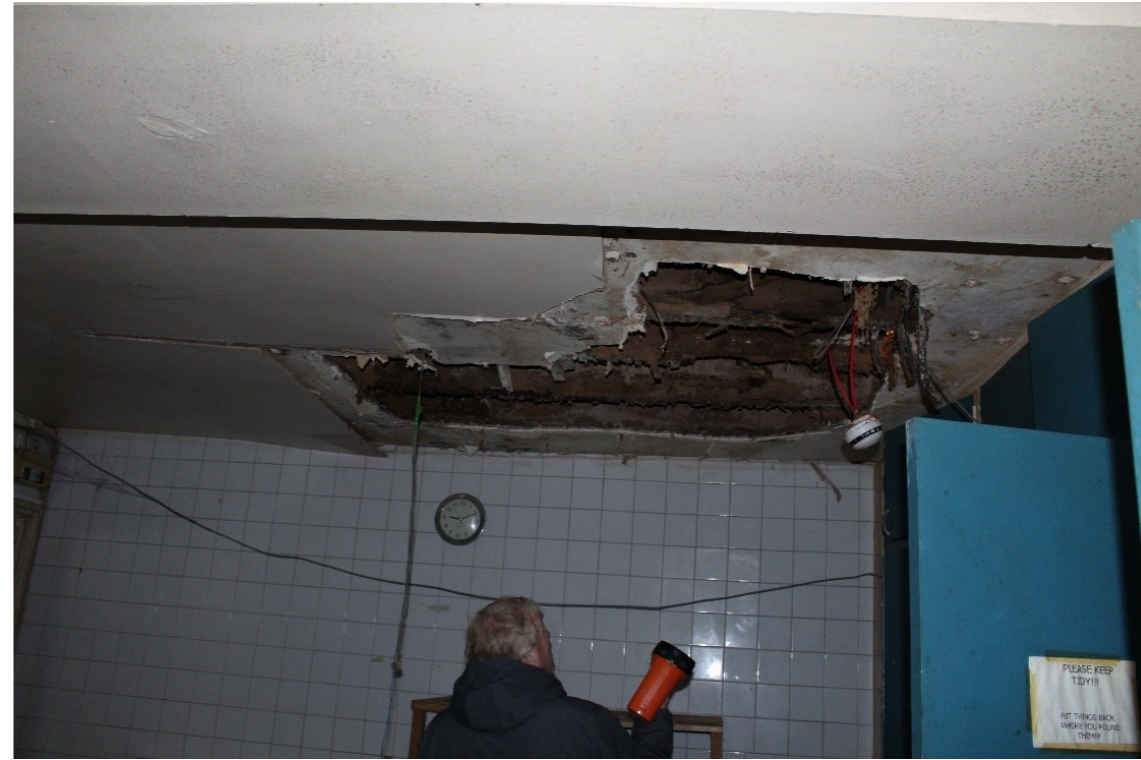
Fig. 6 Roof leaks have caused decay, collapsed and loss of the historic structure below in multiple areas over 3 floors.

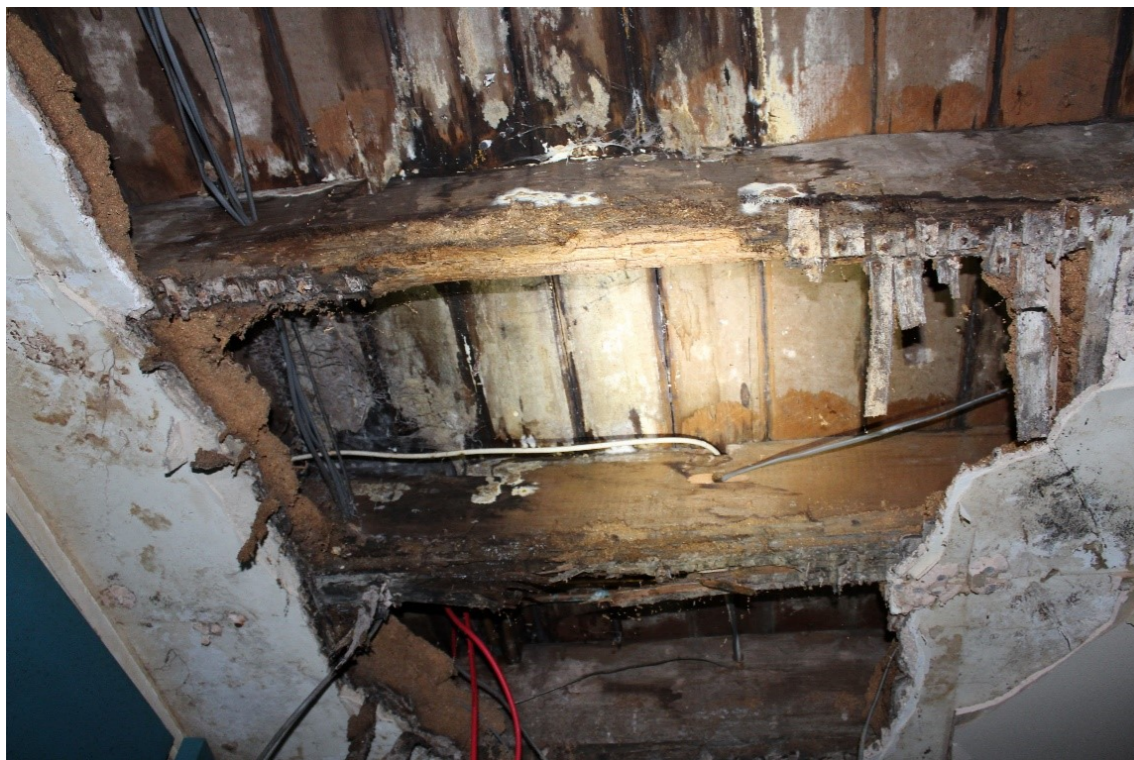
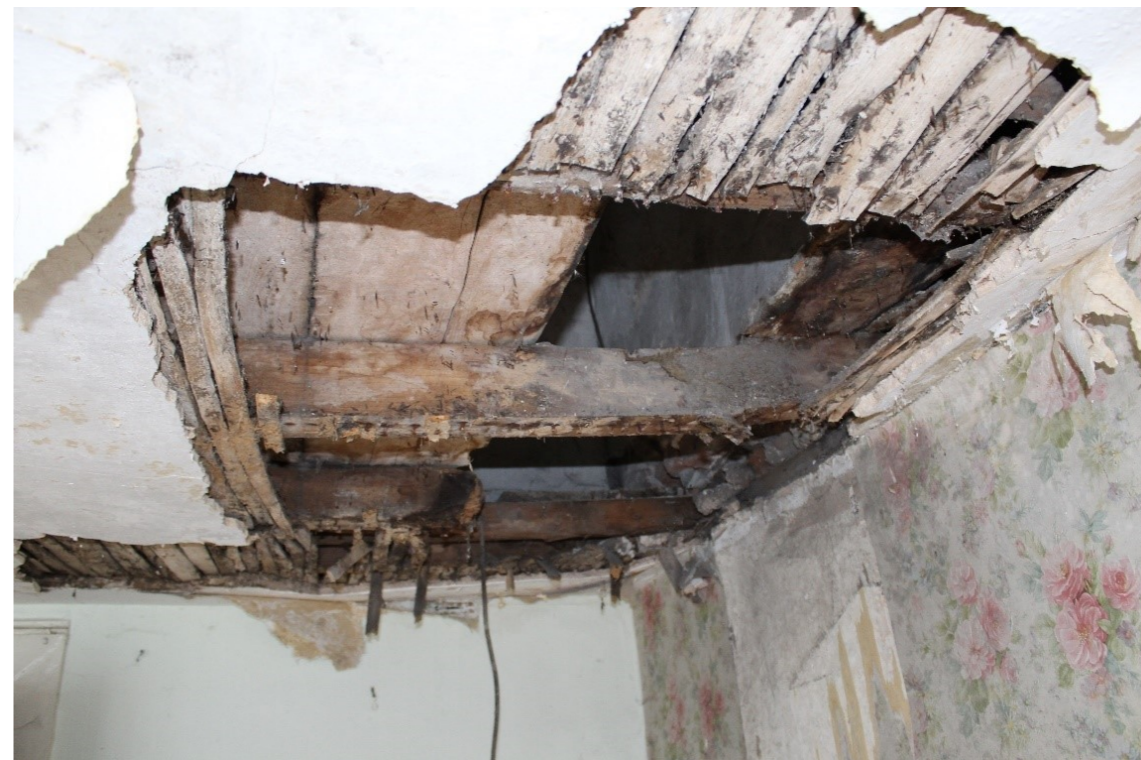
25 . The Victoria Hotel, Newnham

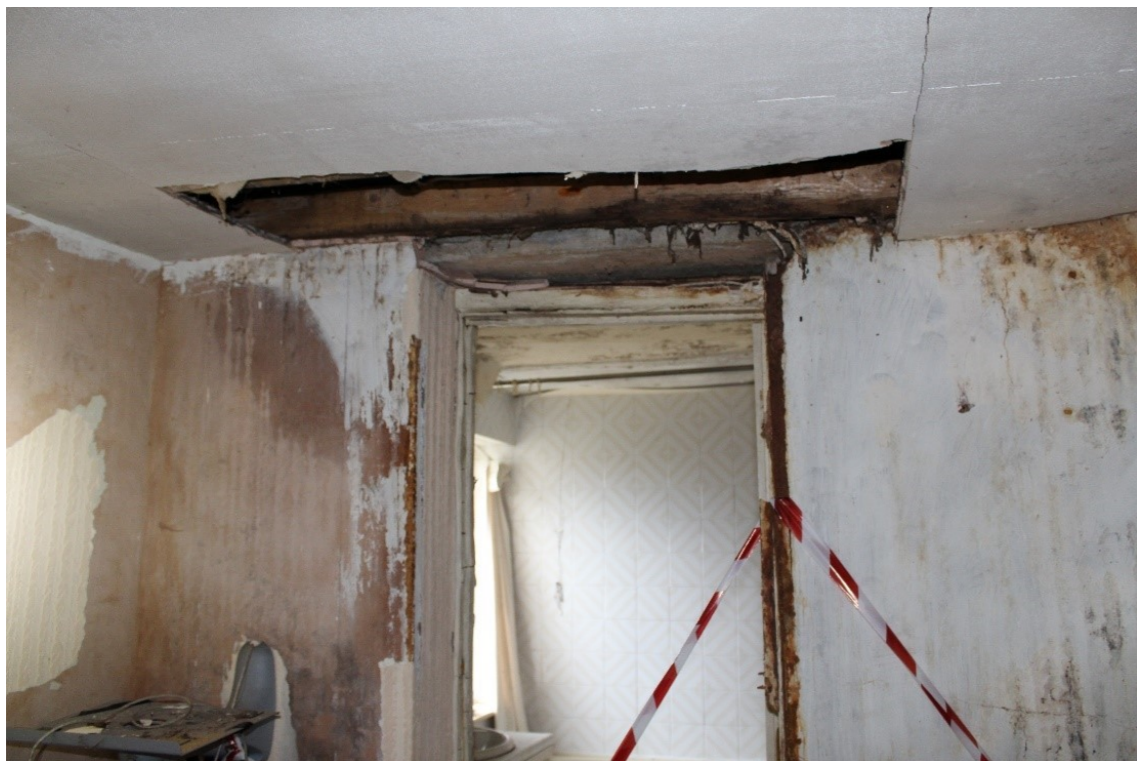
Fig. 9 Roof leaks have caused decay, collapsed and loss of the historic structure below in multiple areas over 3 floors.

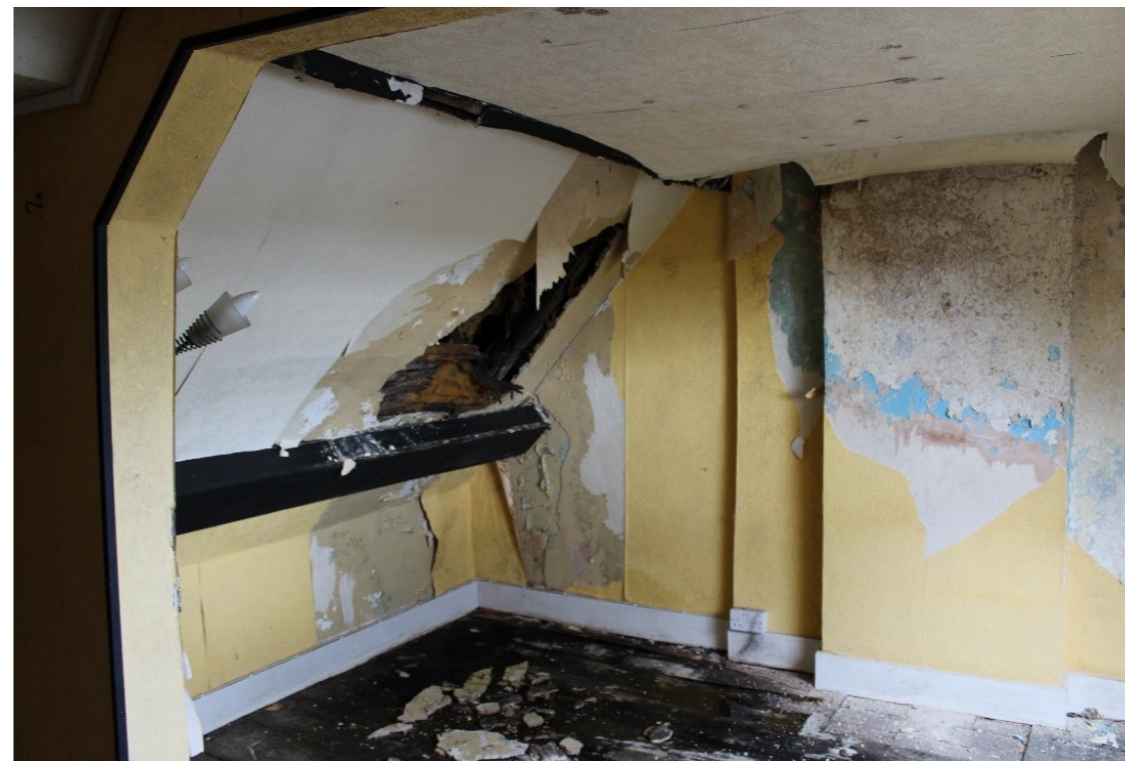
Fig. 10 Roof leaks have caused decay, collapsed and loss of the historic structure below in multiple areas over 3 floors.

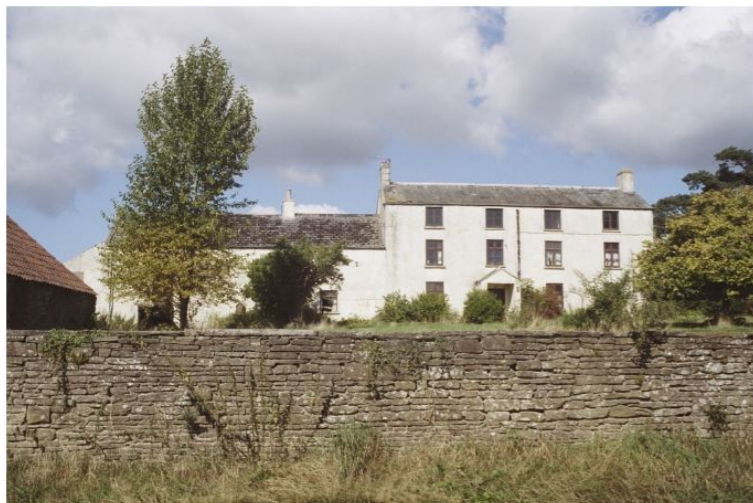
Farmhouse in 2005 (photo taken from <https://historicengland.org.uk/listing/the-list/list-entry/1299228>)

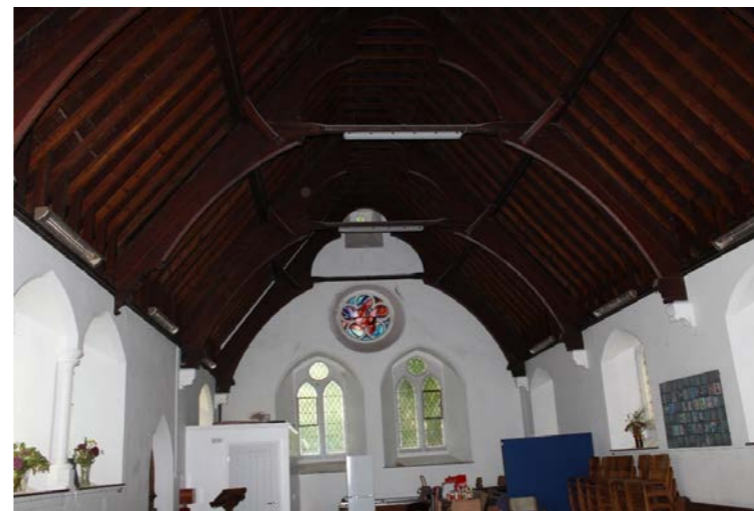
Fig.8 Internal View of Church

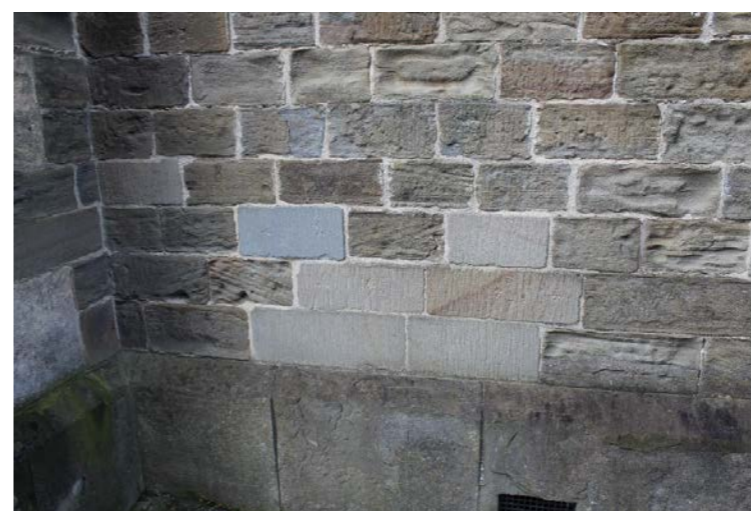
Fig. 8 Replacement of defective stonework

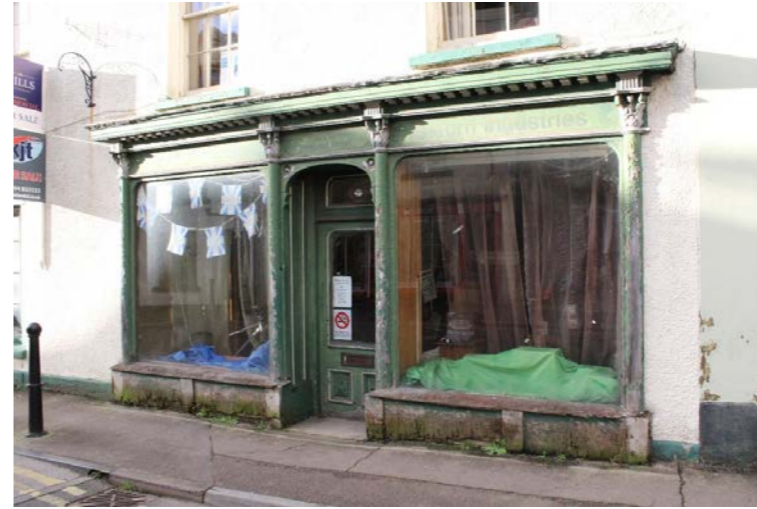
Fig. 2 Timber shop front - in poor condition

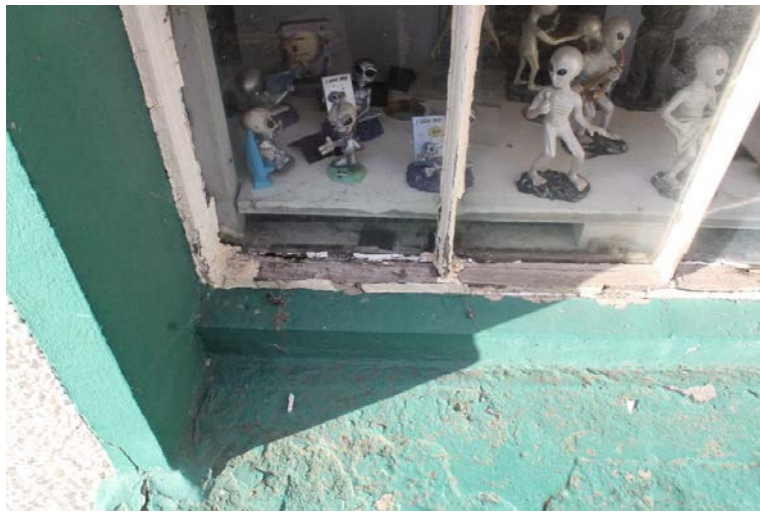
Fig. 3 Front left ground floor timber window frame - in poor condition

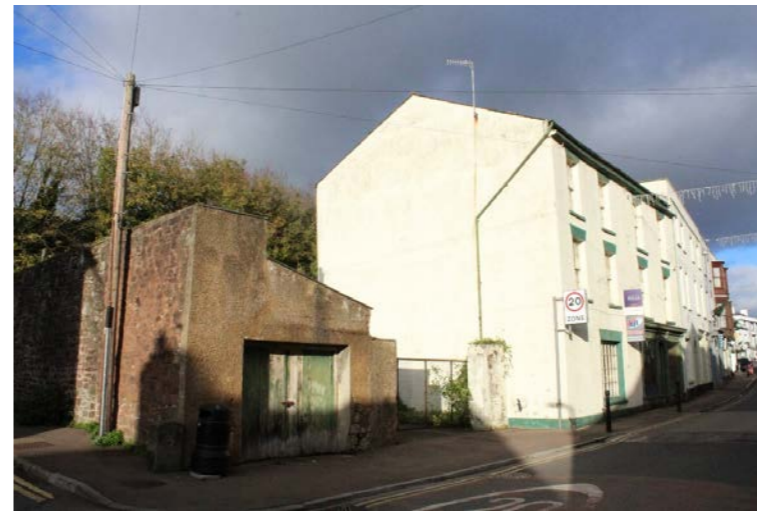
Fig. 4 Side elevation - detached curtilage garage in foreground - is in poor condition

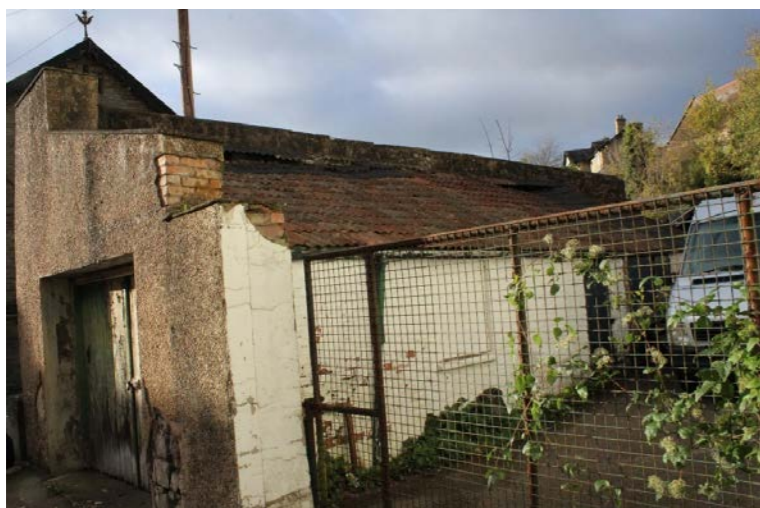
Fig. 5 Front and side elevation of detached curtilage listed garage - is in poor condition and roof has partially collapsed

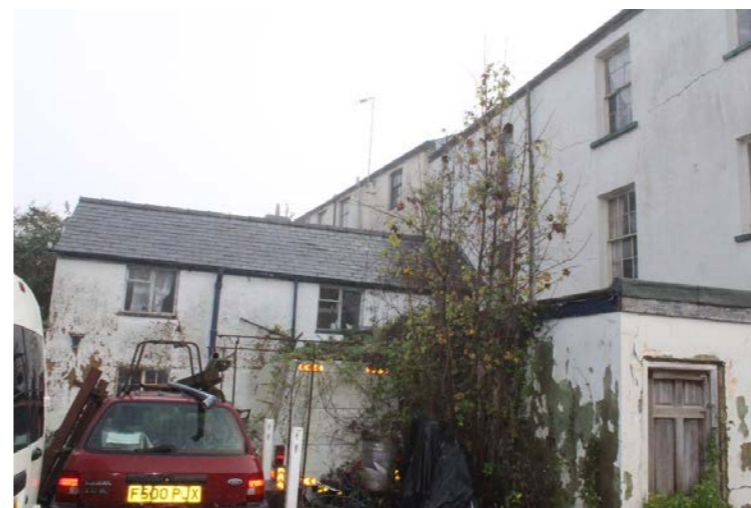
Fig. 6 Rear elevation - deep cracking is evident in external walls and is generally in poor condition

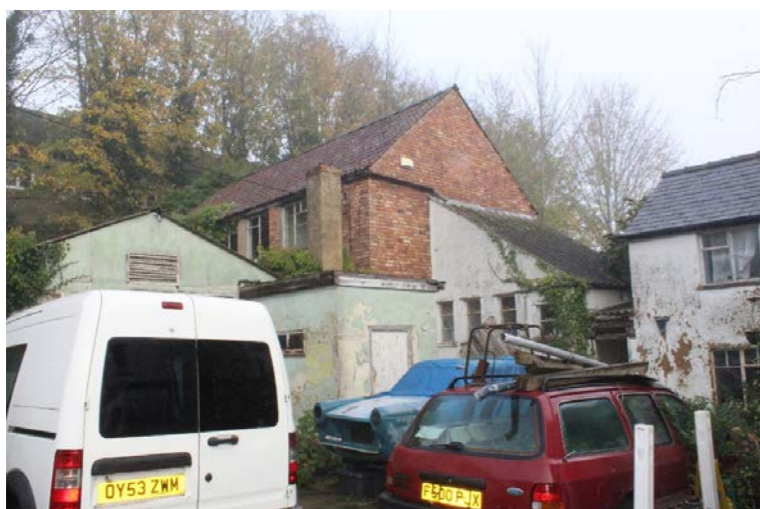
Fig. 7 Curtilage listed printing works and various 20th century outbuildings at rear are in poor condition

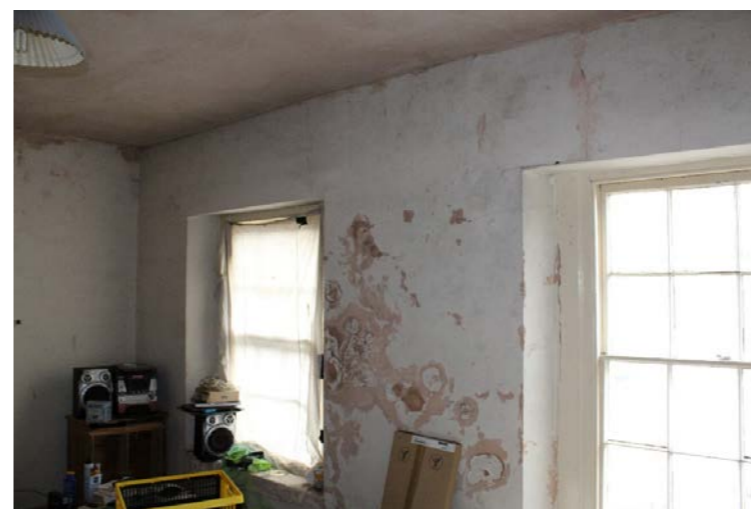
Fig. 8 Internal view of main building external walls - ingress of water has deteriorated wall/ceiling finishes and is in poor condition

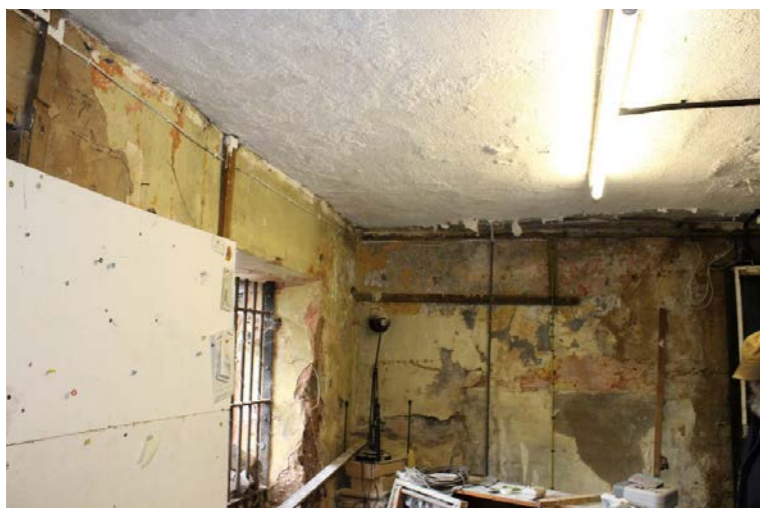
Fig. 9 Internal view of rear building - ingress of water has deteriorated wall/ceiling finishes and is in poor condition

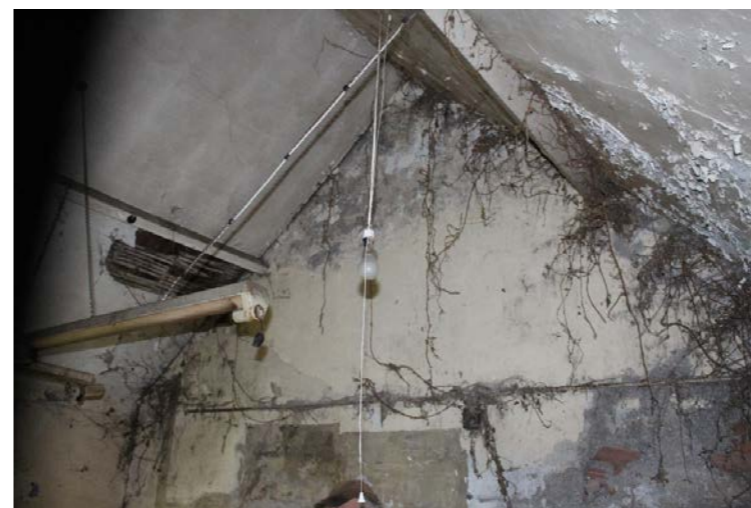
Fig. 10 Internal view of print works building - ingress of water has deteriorated finishes; the ceiling and timber floor has partially collapsed and is in poor condition
